CLIMATE CHANGE & MARKETS FOR CHANGE PROGRAMMES

BUILDING MARKET RESILIENCE TO CLIMATE CHANGE

FIJI ASSESSMENT REPORT
DECEMBER 2016

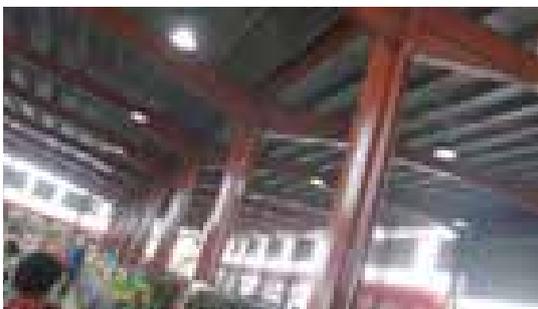
Lautoka Market: Too much glass at height, causes heat and glare

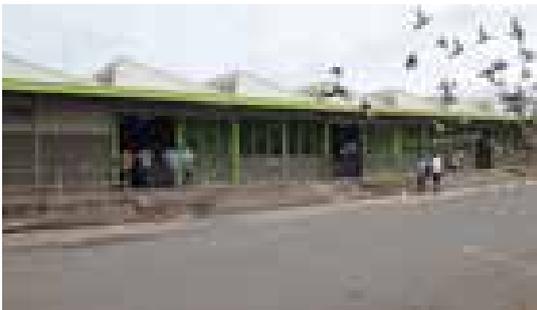
Nadi Market: Zigzag design to roof of Mudaliar Wing creates internal leakage issues

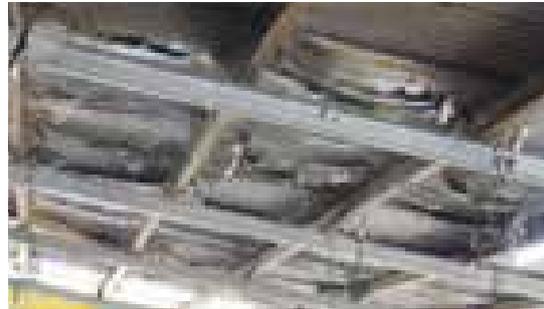
foil lining does help with heat reduction, although ongoing maintenance is required to ensure the longevity of the foil.

Tavua Market: Poor condition of foil lining to roof

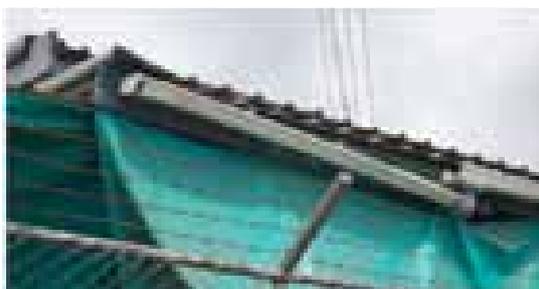
Tavua Market: Detached guttering

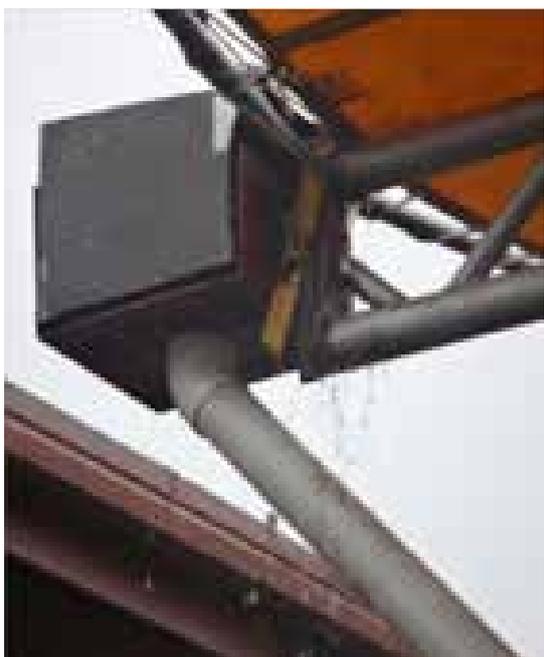
Suva Market: Overflowing guttering in heavy rain

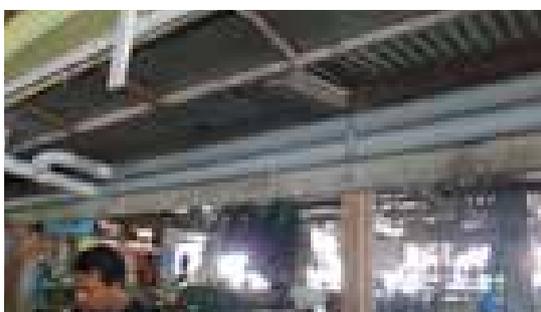
area. The overhead guttering between the new development and the older produce hall leaks throughout.

Savusavu Market: Overhead internal guttering between extensions

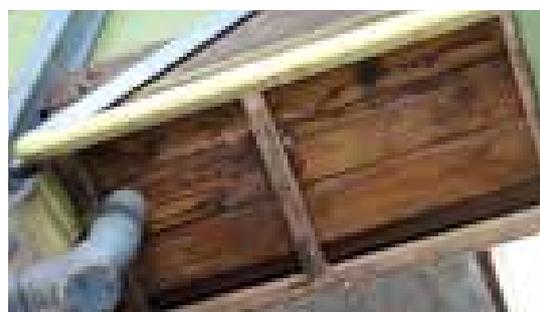
Nadi Market: Ample evidence of leakage from overhead, internal guttering

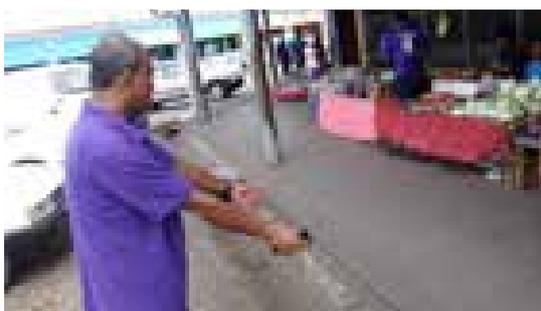
Drainage is also a problem. Often it is an open, cement ditch that collects rubbish (and water when drainage is poor), smells and is a health and safety hazard. At Ba Market, the entire original market is surrounded by a deep ditch, the depth of which has seen vehicles fall into it, and, vendors say, have had to be lifted out. Similarly, at Savusavu Market, one casual vendor has positioned a table in the ditch, because of its depth.

Ba Market: Deep drainage ditch surrounds main market

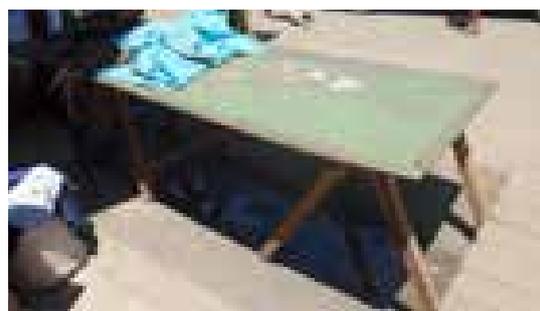
Savusavu Market: Table sited in drainage ditch illustrating depth

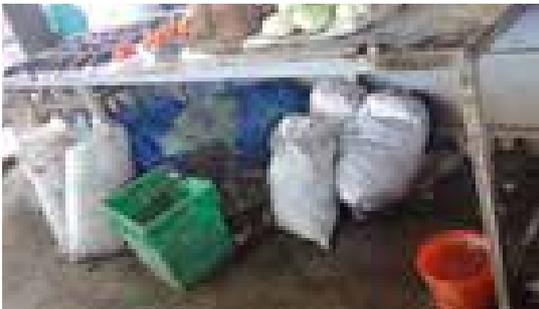
prevent them drying out, the *kai* area is usually wet (Ba), especially when there is no proper drainage outlet (Lautoka).

Lautoka Market: *Kai* section, tables drain into buckets

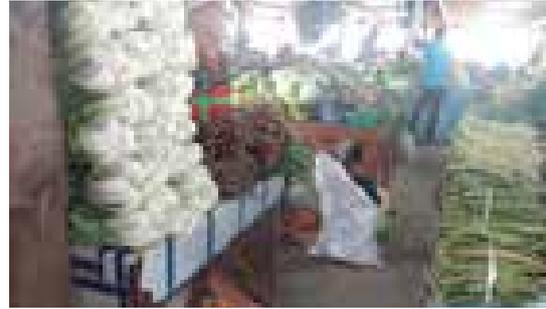
Labasa Market: Poor aisle width

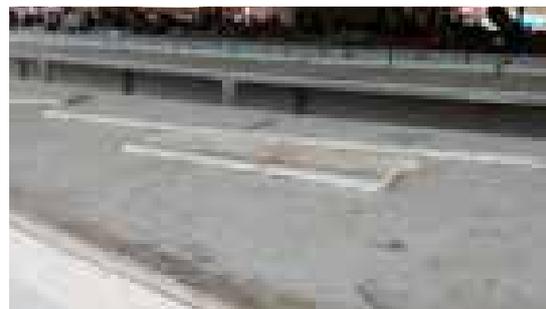
Nadi Market: New, wooden table tops showing signs of wear and tear

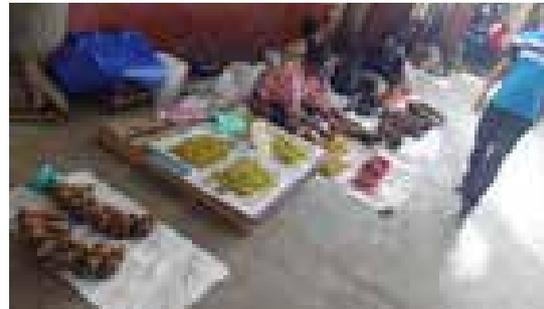
Lautoka Market: Polished floor, slippery when wet

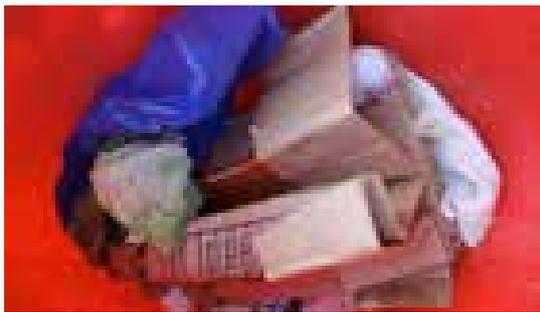
Labasa Market: Mixed rubbish in waste-collection bins

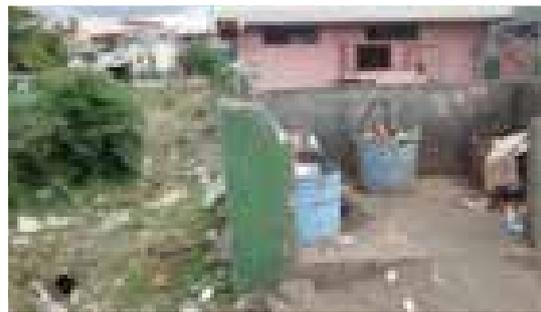
Tavua Market: Rubbish strewn around rubbish collection site

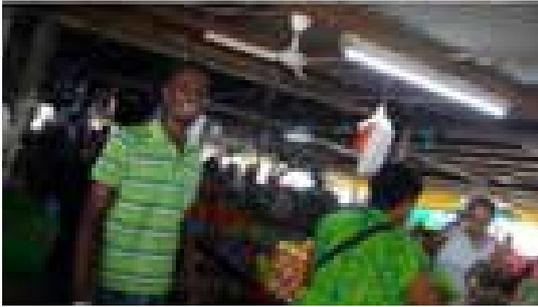
Tavua Market: Low ceiling height and conventional lighting makes area hot

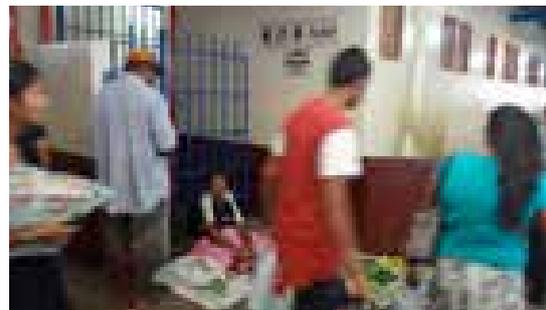
Lautoka Market: Disabled toilets locked and blocked

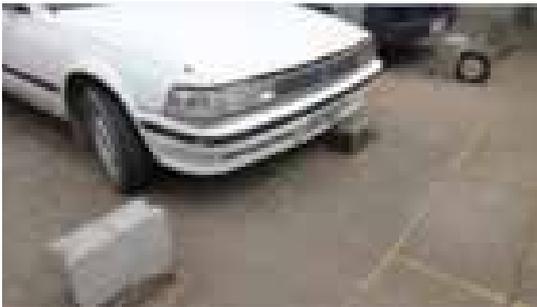
Tavua Market: Market parking spaces very close to casual vendors
