CLIMATE CHANGE & MARKETS FOR CHANGE PROGRAMMES

BUILDING MARKET RESILIENCE TO CLIMATE CHANGE

FIJI ASSESSMENT REPORT
DECEMBER 2016

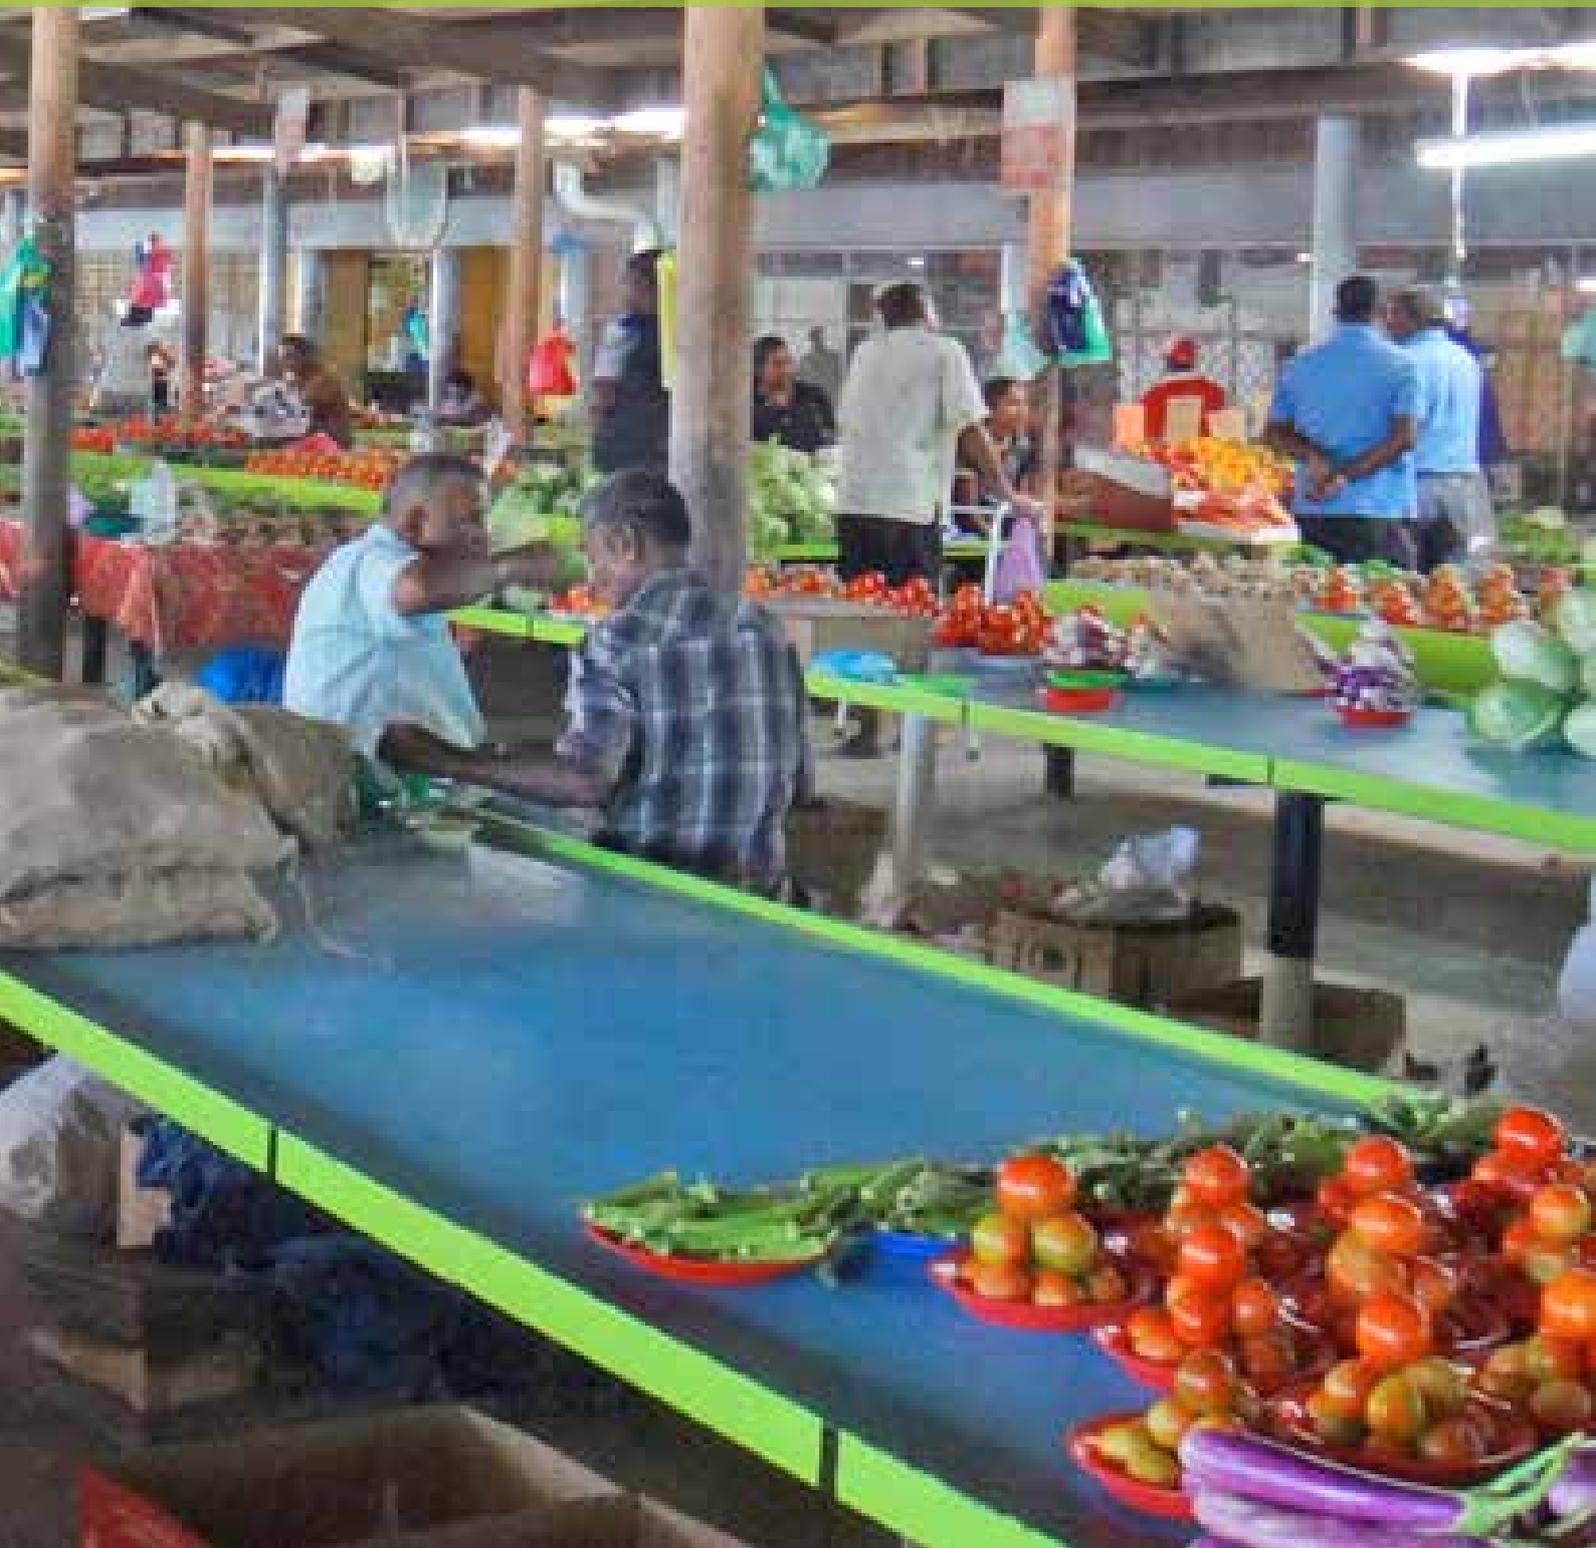
Ba Market

- Frequent, severe flooding
- No plans to redevelop or relocate market
- Dry goods inside market building; fruit and vegetables outside, sold undercover and along corridors
- Corridors have little shade from rain or sun; vendors use own coverings to protect themselves
- Rafters of market very dusty
- Open drainage ditch around circumference of market building - health and safety issue
- Vendors watchful and adaptable to flooding

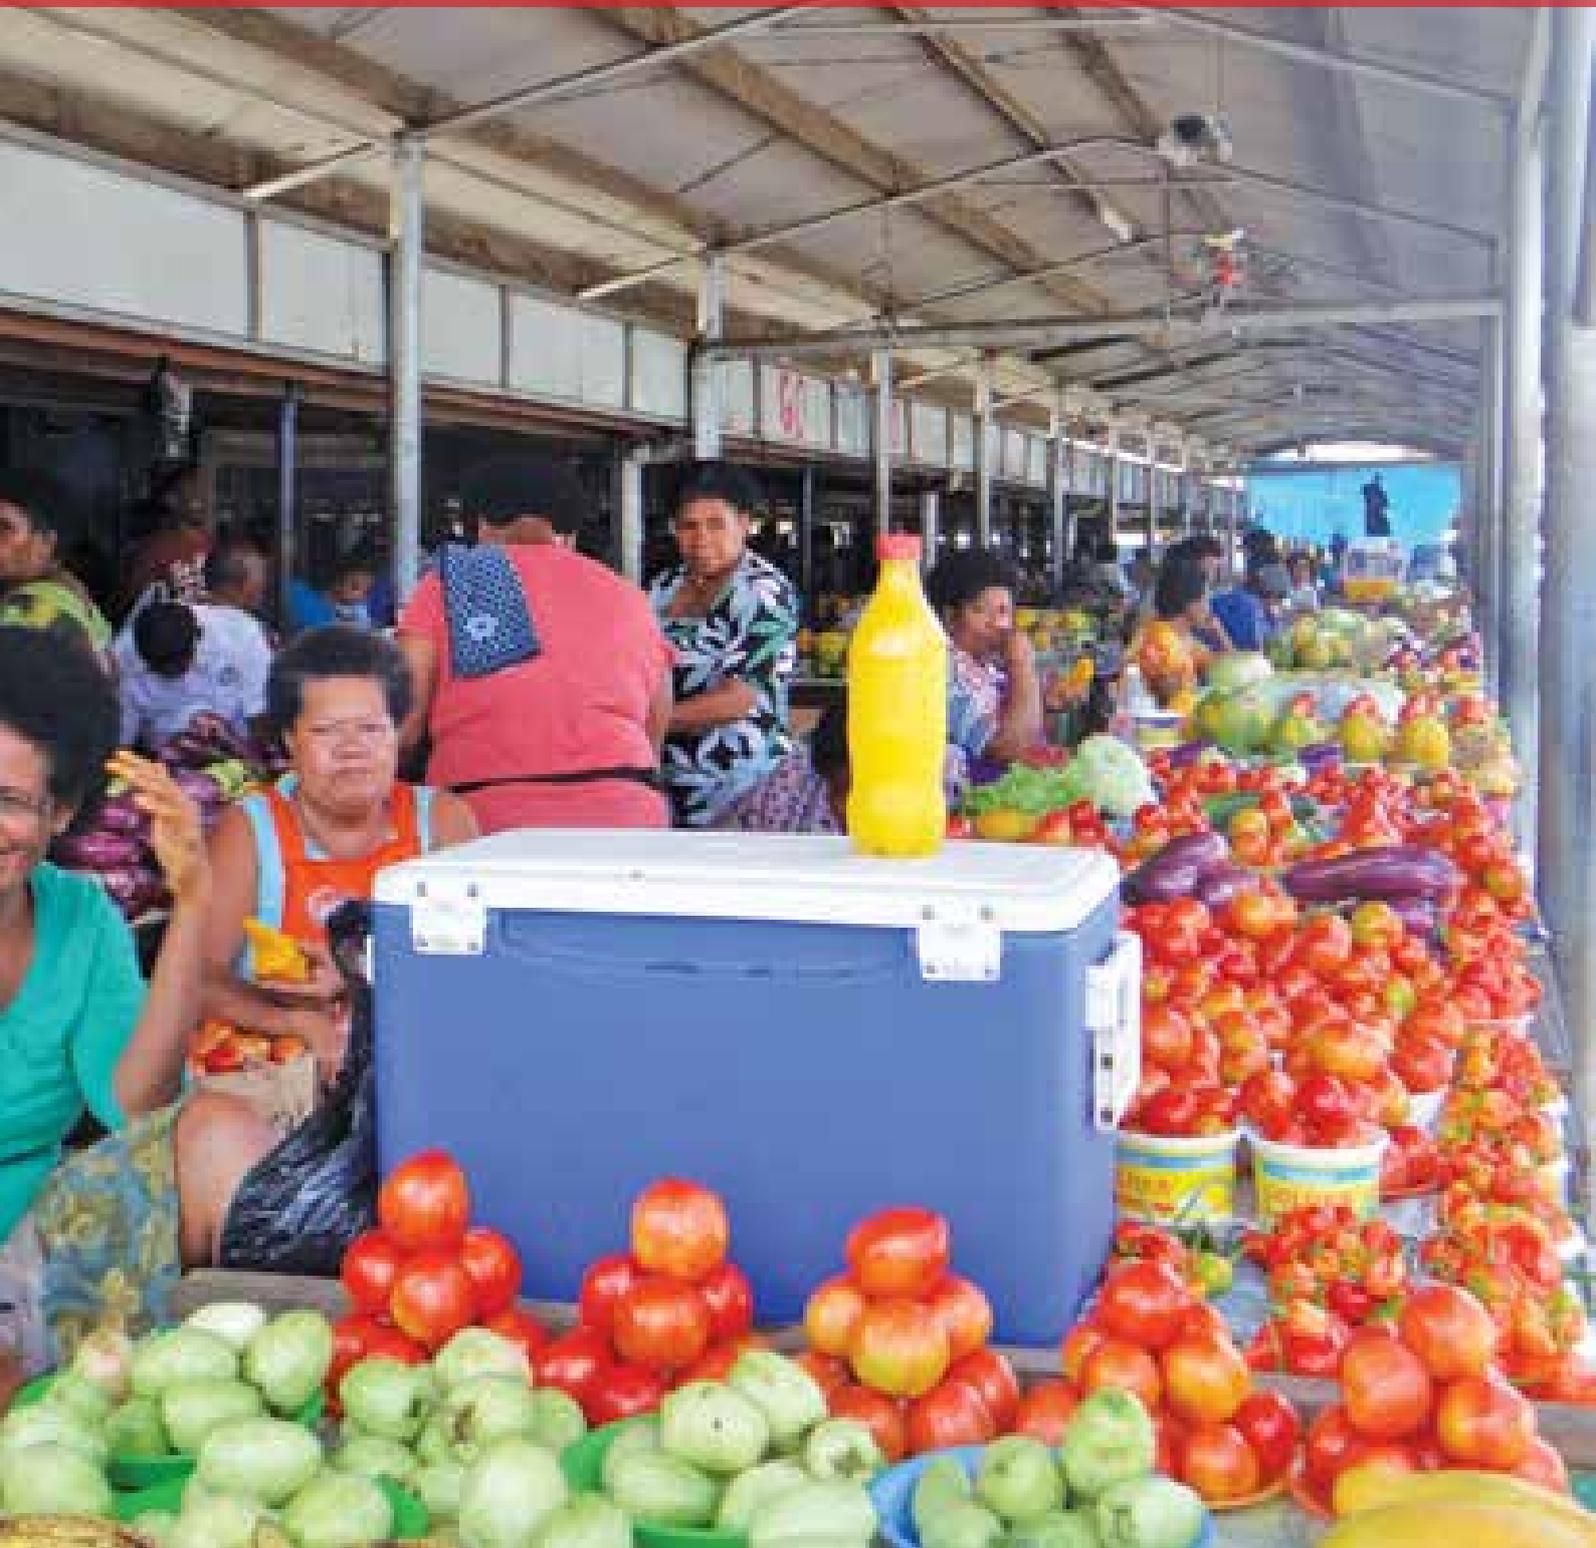
Labasa Market

- Frequent, severe flooding because of proximity to Labasa River
- Plans to relocate market to Subrail Park - still within flood - risk zone
- Currently sited on reclaimed land
- Heat and ventilation in produce halls main ongoing issue
- Hot sun affects casual vendors and permanent vendors located near perimeter of halls
- Flies and mosquitoes near river an issue
- Dusty car park near cooked - food vendors
- No back - up generator

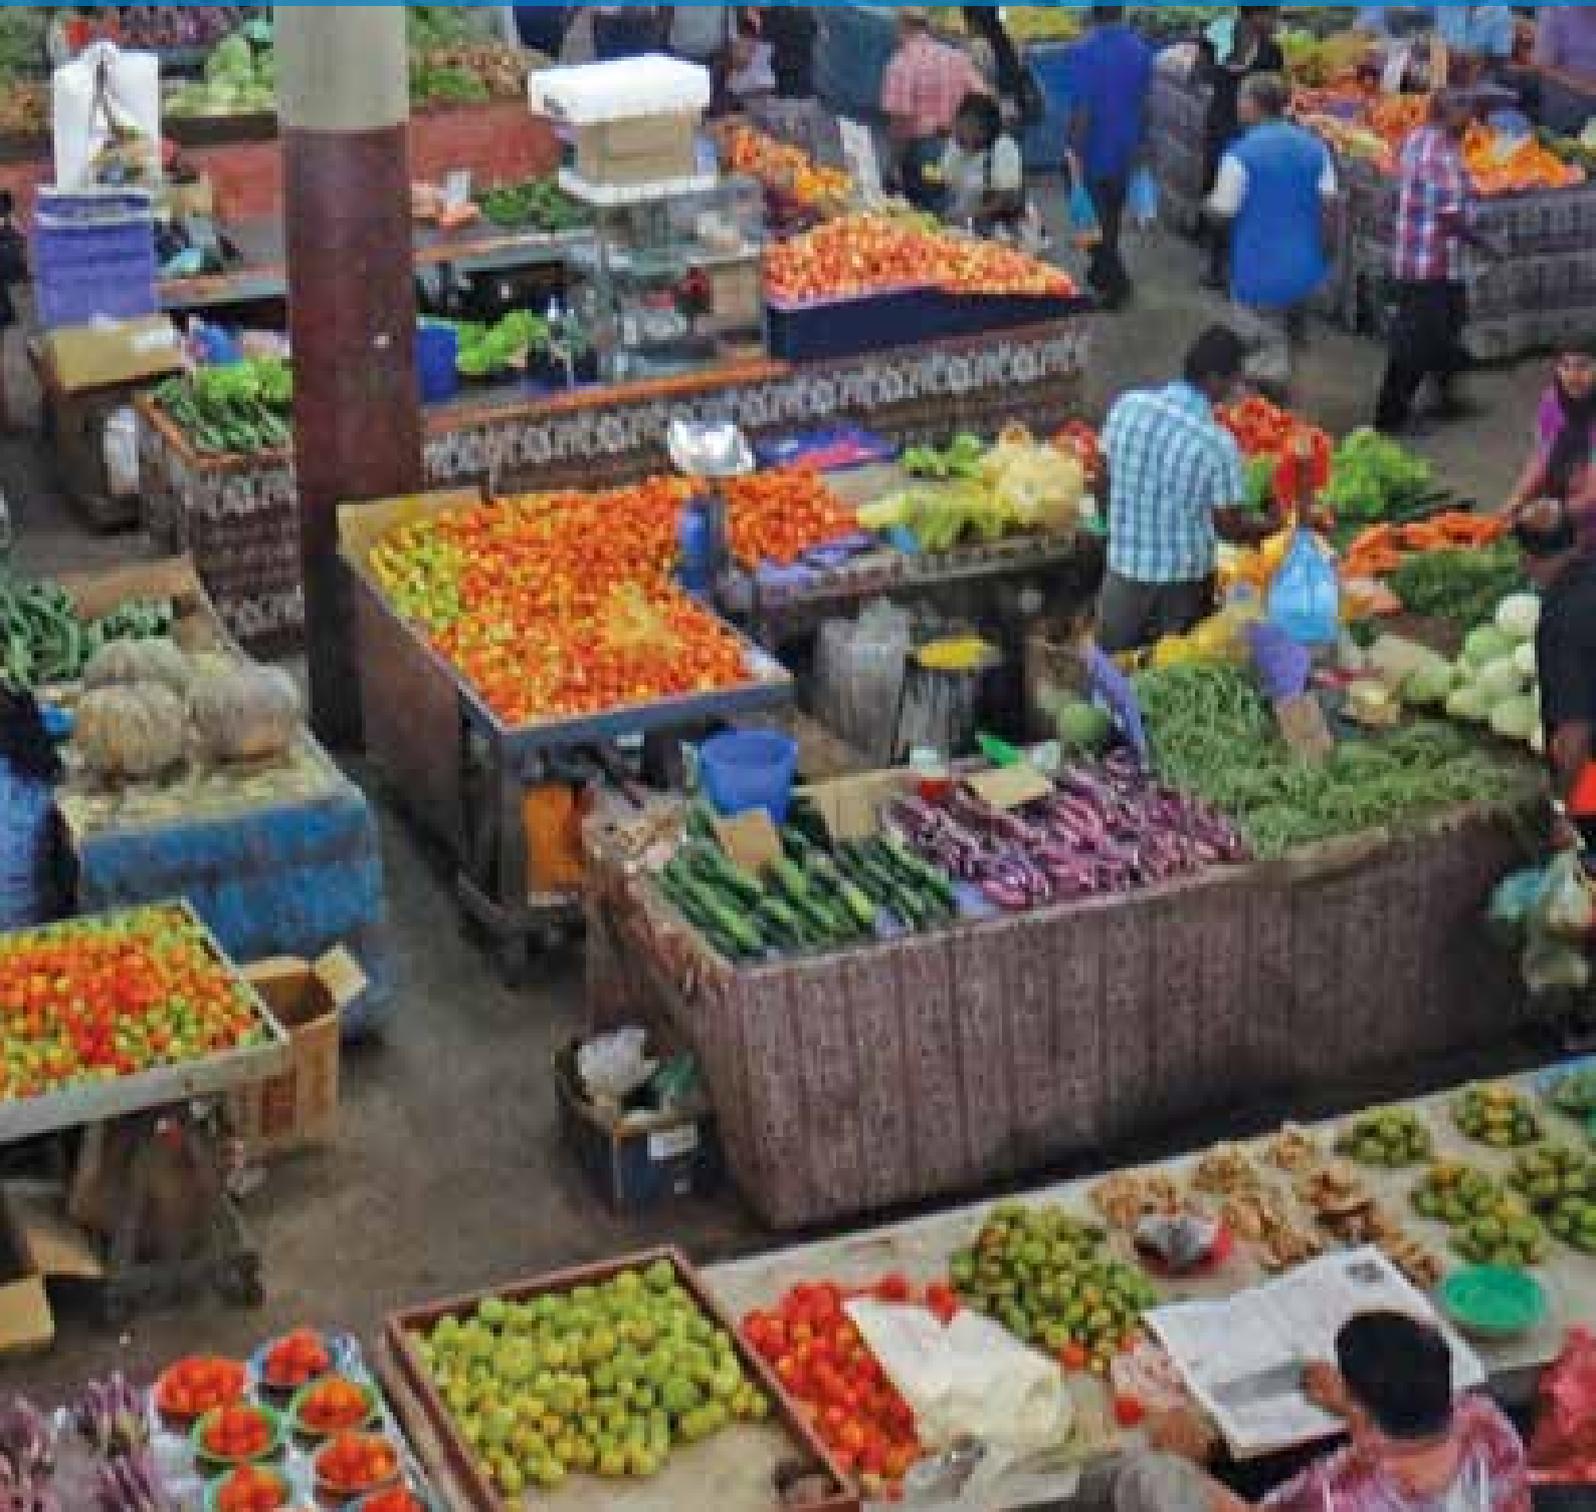
Lautoka Market

- Tsunami risk because of proximity to coast
- No major rivers in the vicinity
- No plans to redevelop or relocate market, but restricted site in down town Lautoka
- New shed has too many windows - too bright and hot
- Casual vendors sell fish and seafood from floor with customers walking past
- Juice vendors on Namoli Green have no protection from elements
- Old market uneven flooring, range of selling tables and poor ventilation
- *Kai* section - tables drain into buckets, creating wet floor surfaces

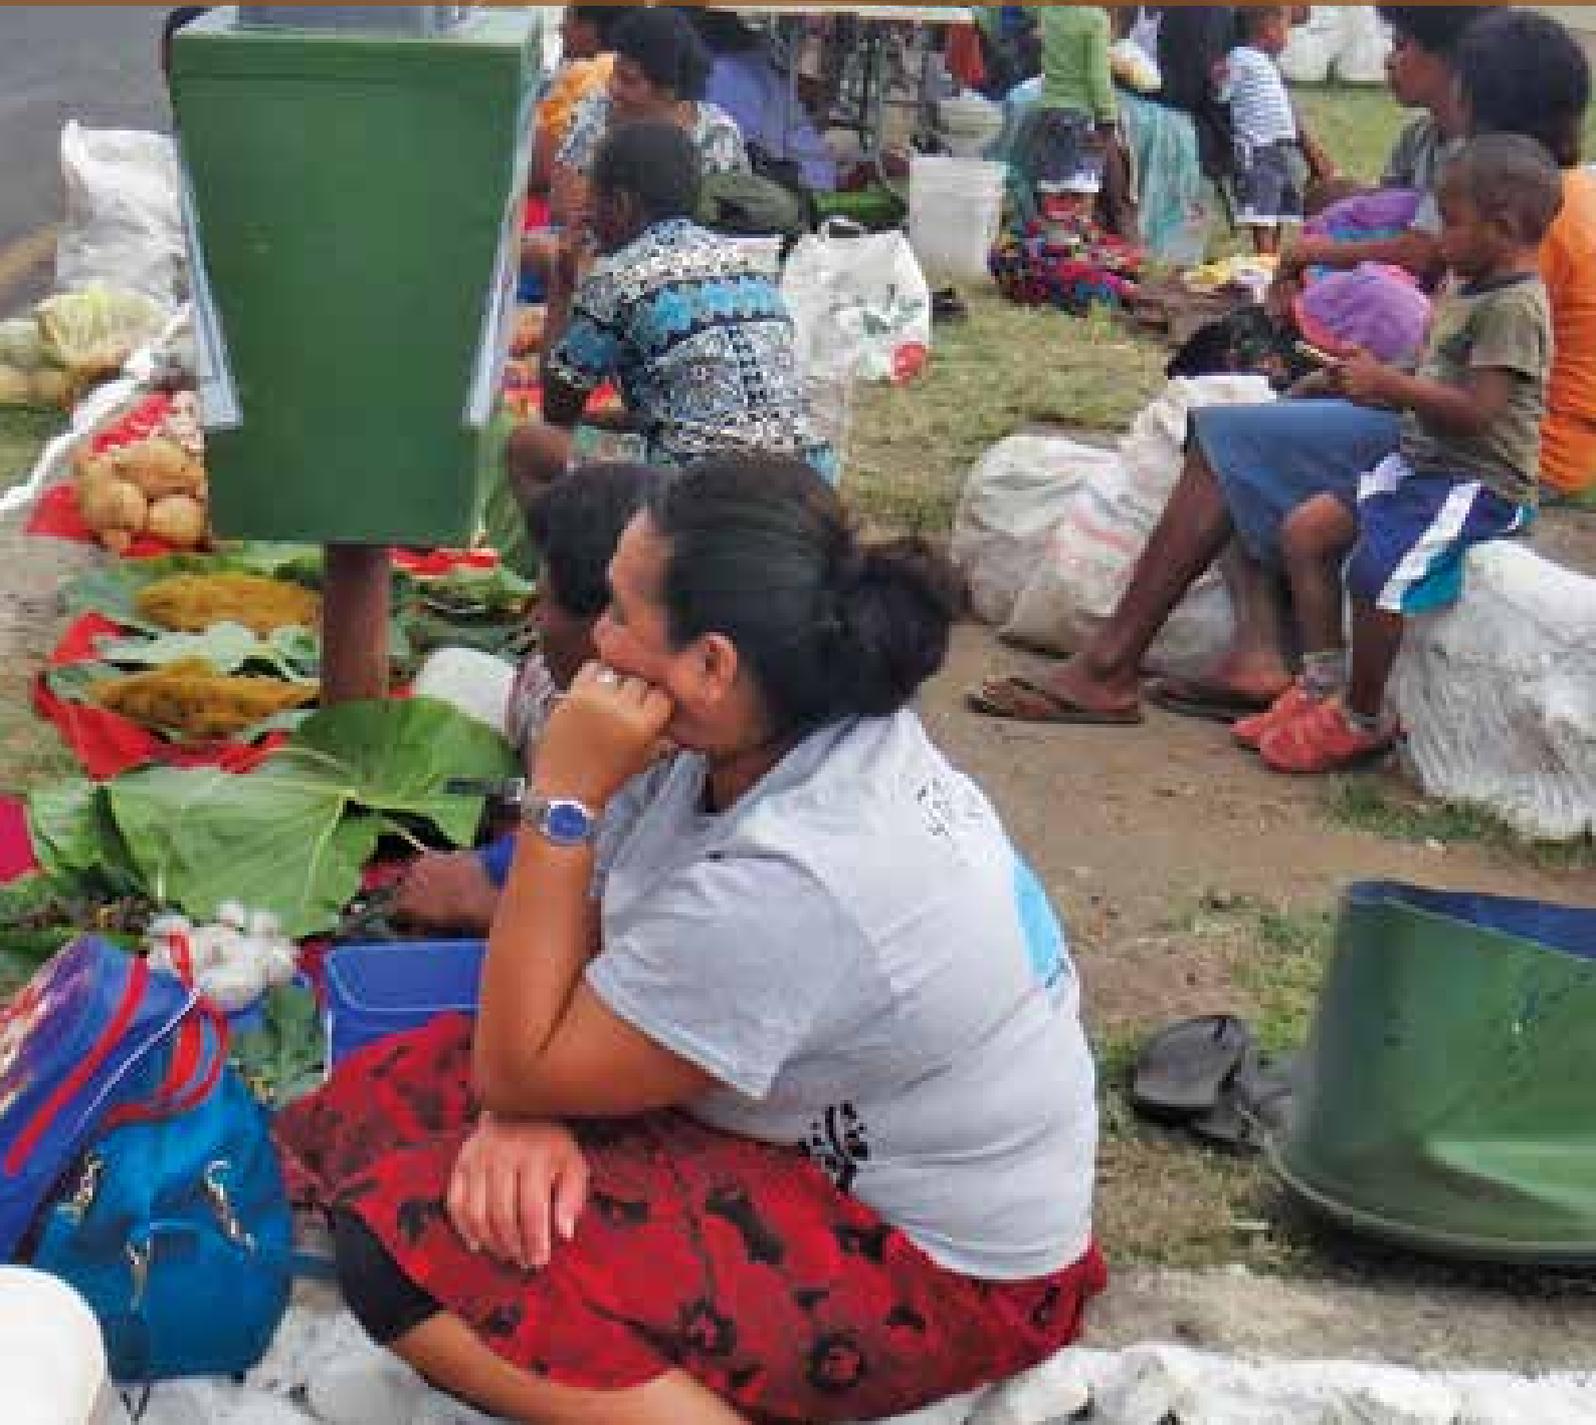
Levuka Market

- Only casual vendors, and all sell on just one day a week, with no overlap between communities/days
- Sales are made along Beach Street, with no protection from the elements
- Immediate proximity to the coast
- Plans to upgrade, extend and reopen the municipal market for produce sales, but vendors very reluctant to move to northern end of town (400m)
- Arrival and departure times for vendors from Moturiki Island are dependent on high-tide times
- No tap other than a public drinking tap on Beach Street
- No apparent drainage outlet for market building, nor tap
- Building is listed on World Heritage list (No.76)

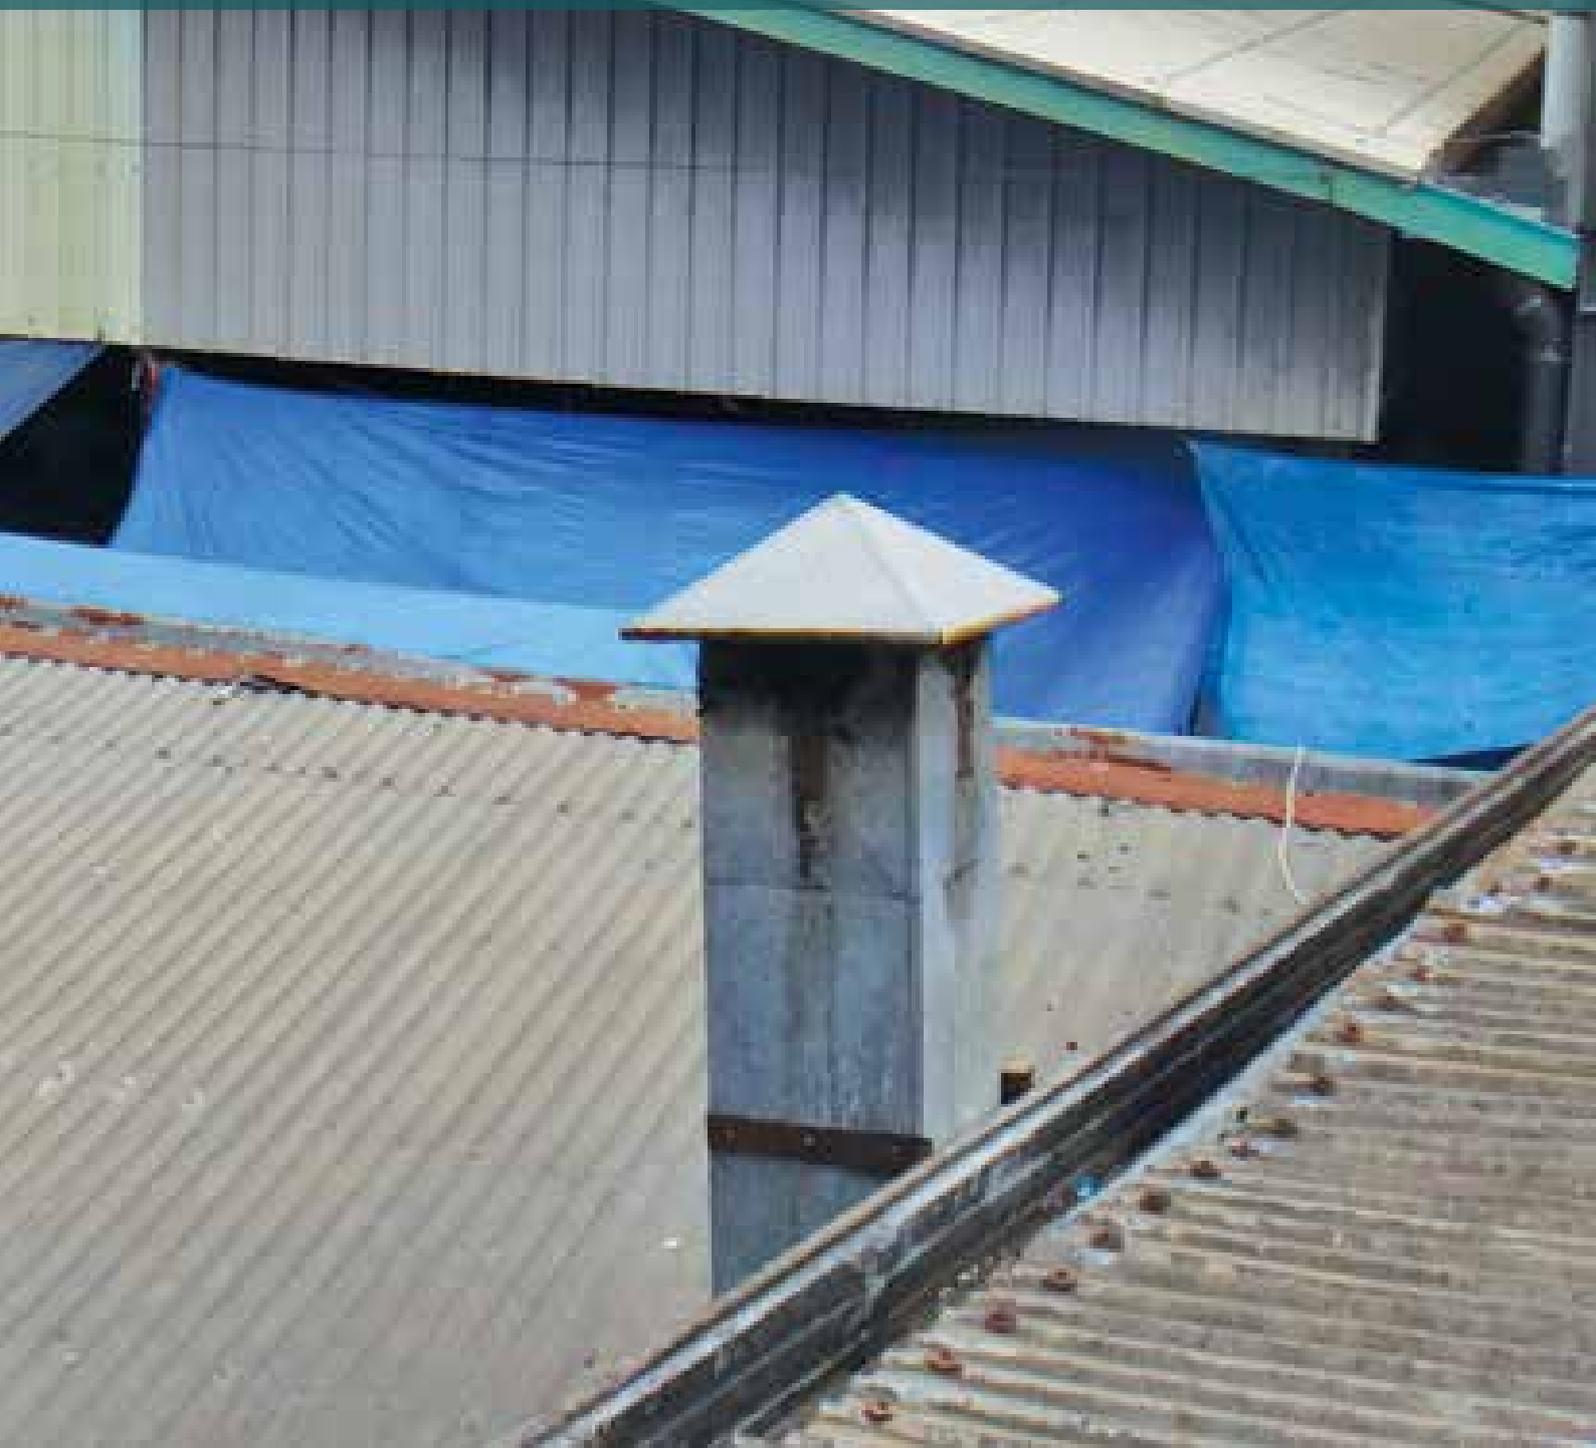
Nadi Market

- Frequent, severe flooding, with flood waters approaching market from two directions - site positioned in meander of Nadi River
- Eclectic mix of produce halls and extensions, and no plans to redevelop or relocate market
- Muduliar Wing - leaking internal guttering crisscrosses ceiling
- Oldest section - low ceiling and poor ventilation, and also poor access because raised platform
- Casual vendors sell from floor in open area of market, between Khatri Wing and restaurant
- Poor plumbing associated with restaurant; stagnant, rancid drain
- *Kai* section sell from floor
- No waste segregation apparent

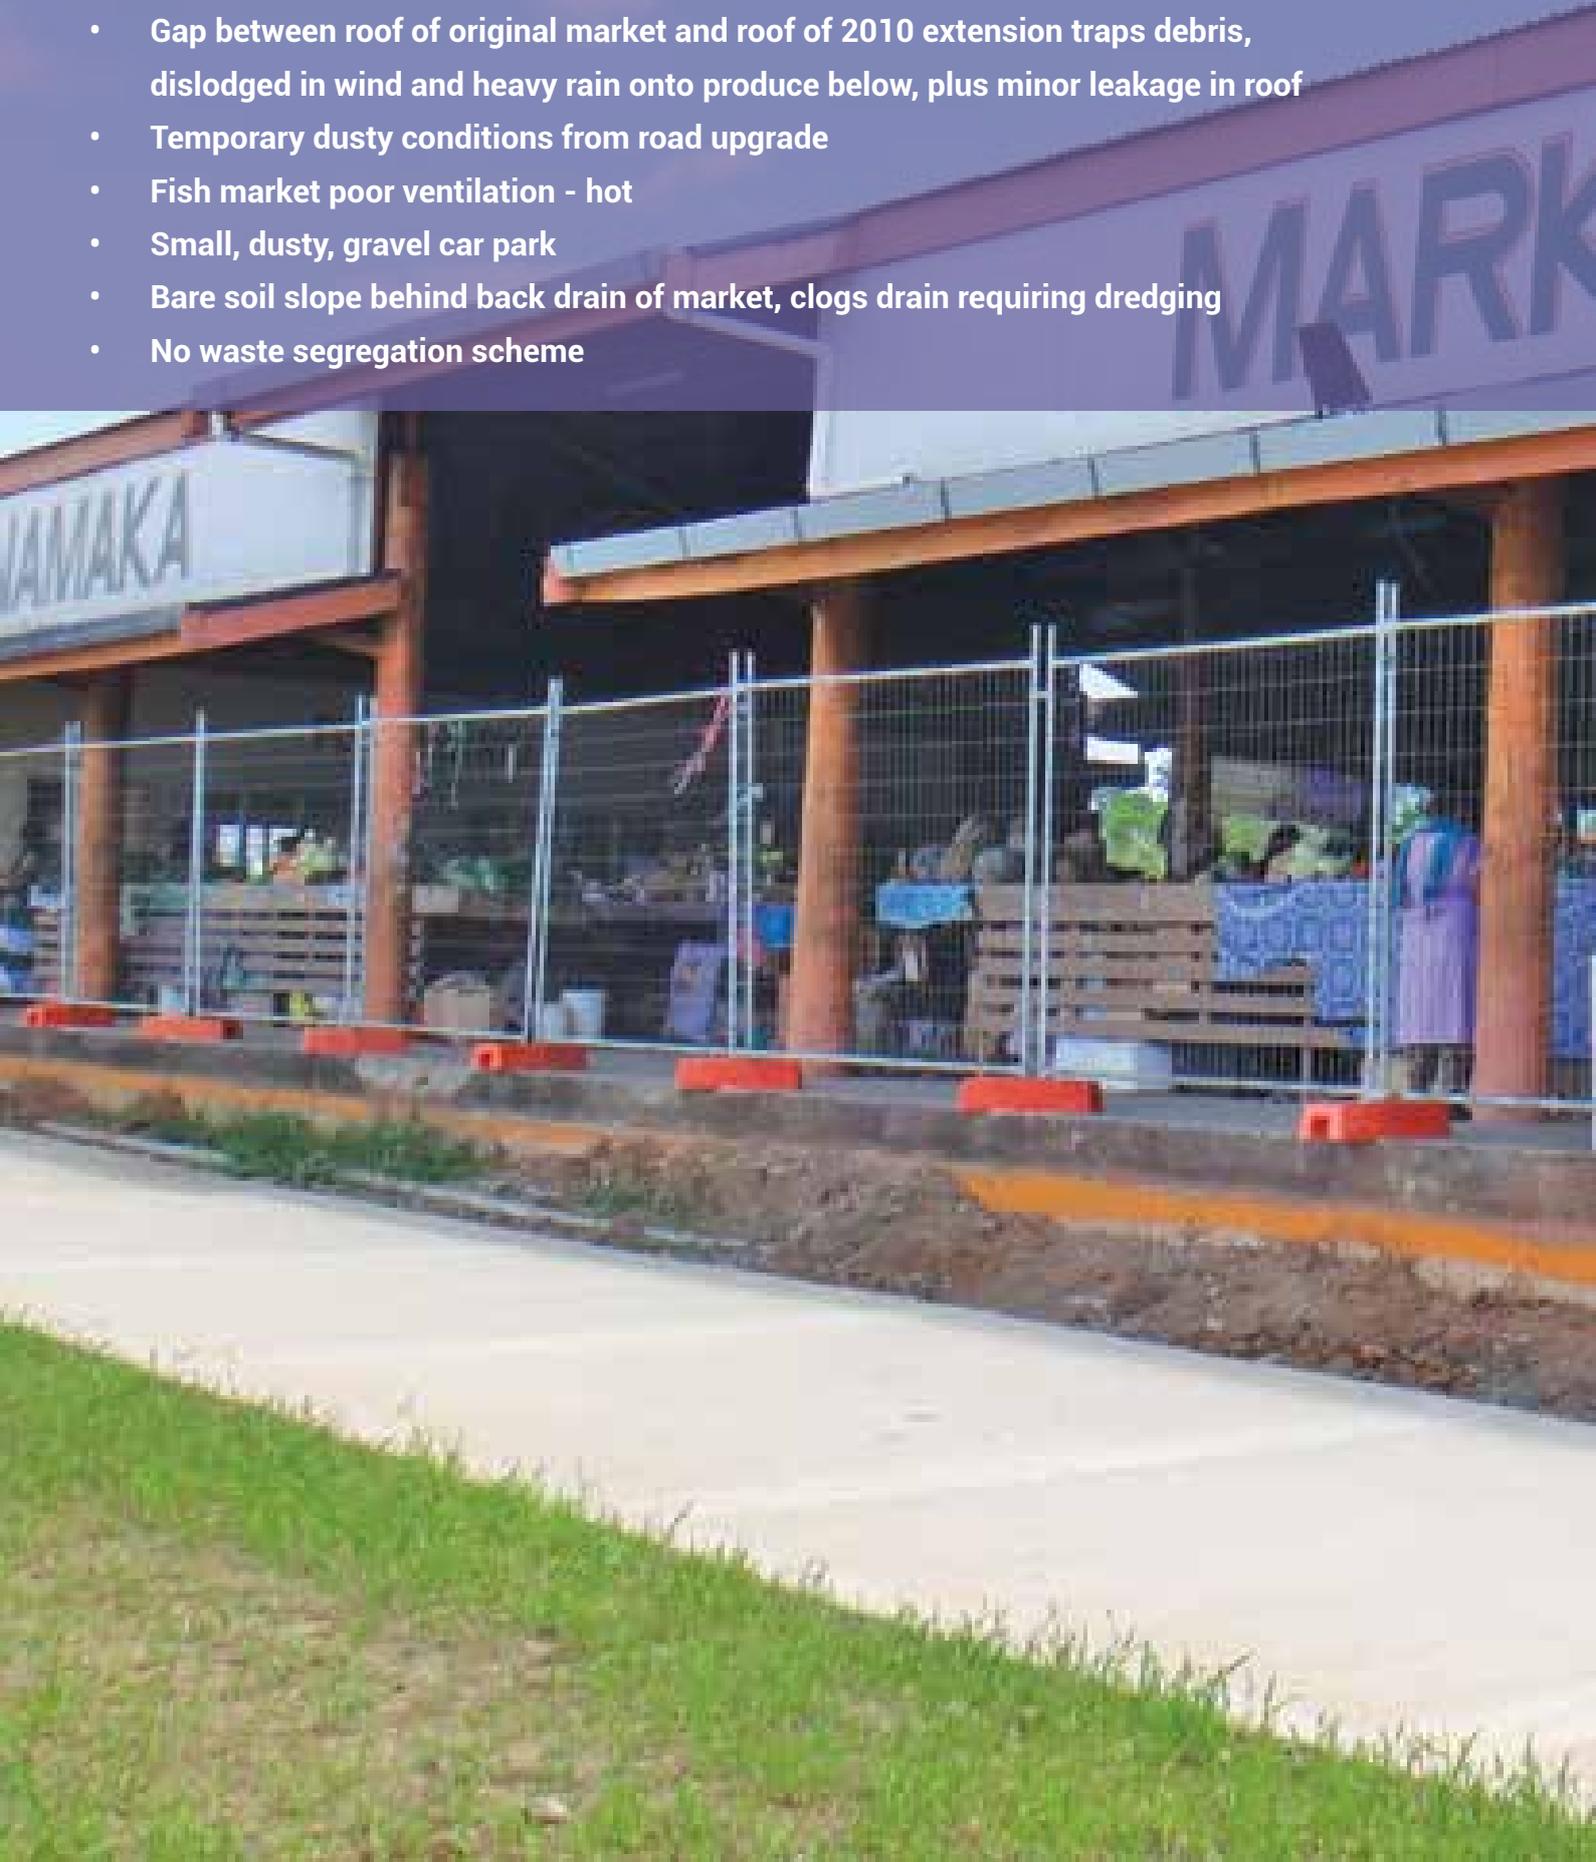
Namaka Market

- No evidence of flooding at the market since it opened 2005
- Plans to extend market with addition of two-storey extension
- Gap between roof of original market and roof of 2010 extension traps debris, dislodged in wind and heavy rain onto produce below, plus minor leakage in roof
- Temporary dusty conditions from road upgrade
- Fish market poor ventilation - hot
- Small, dusty, gravel car park
- Bare soil slope behind back drain of market, clogs drain requiring dredging
- No waste segregation scheme

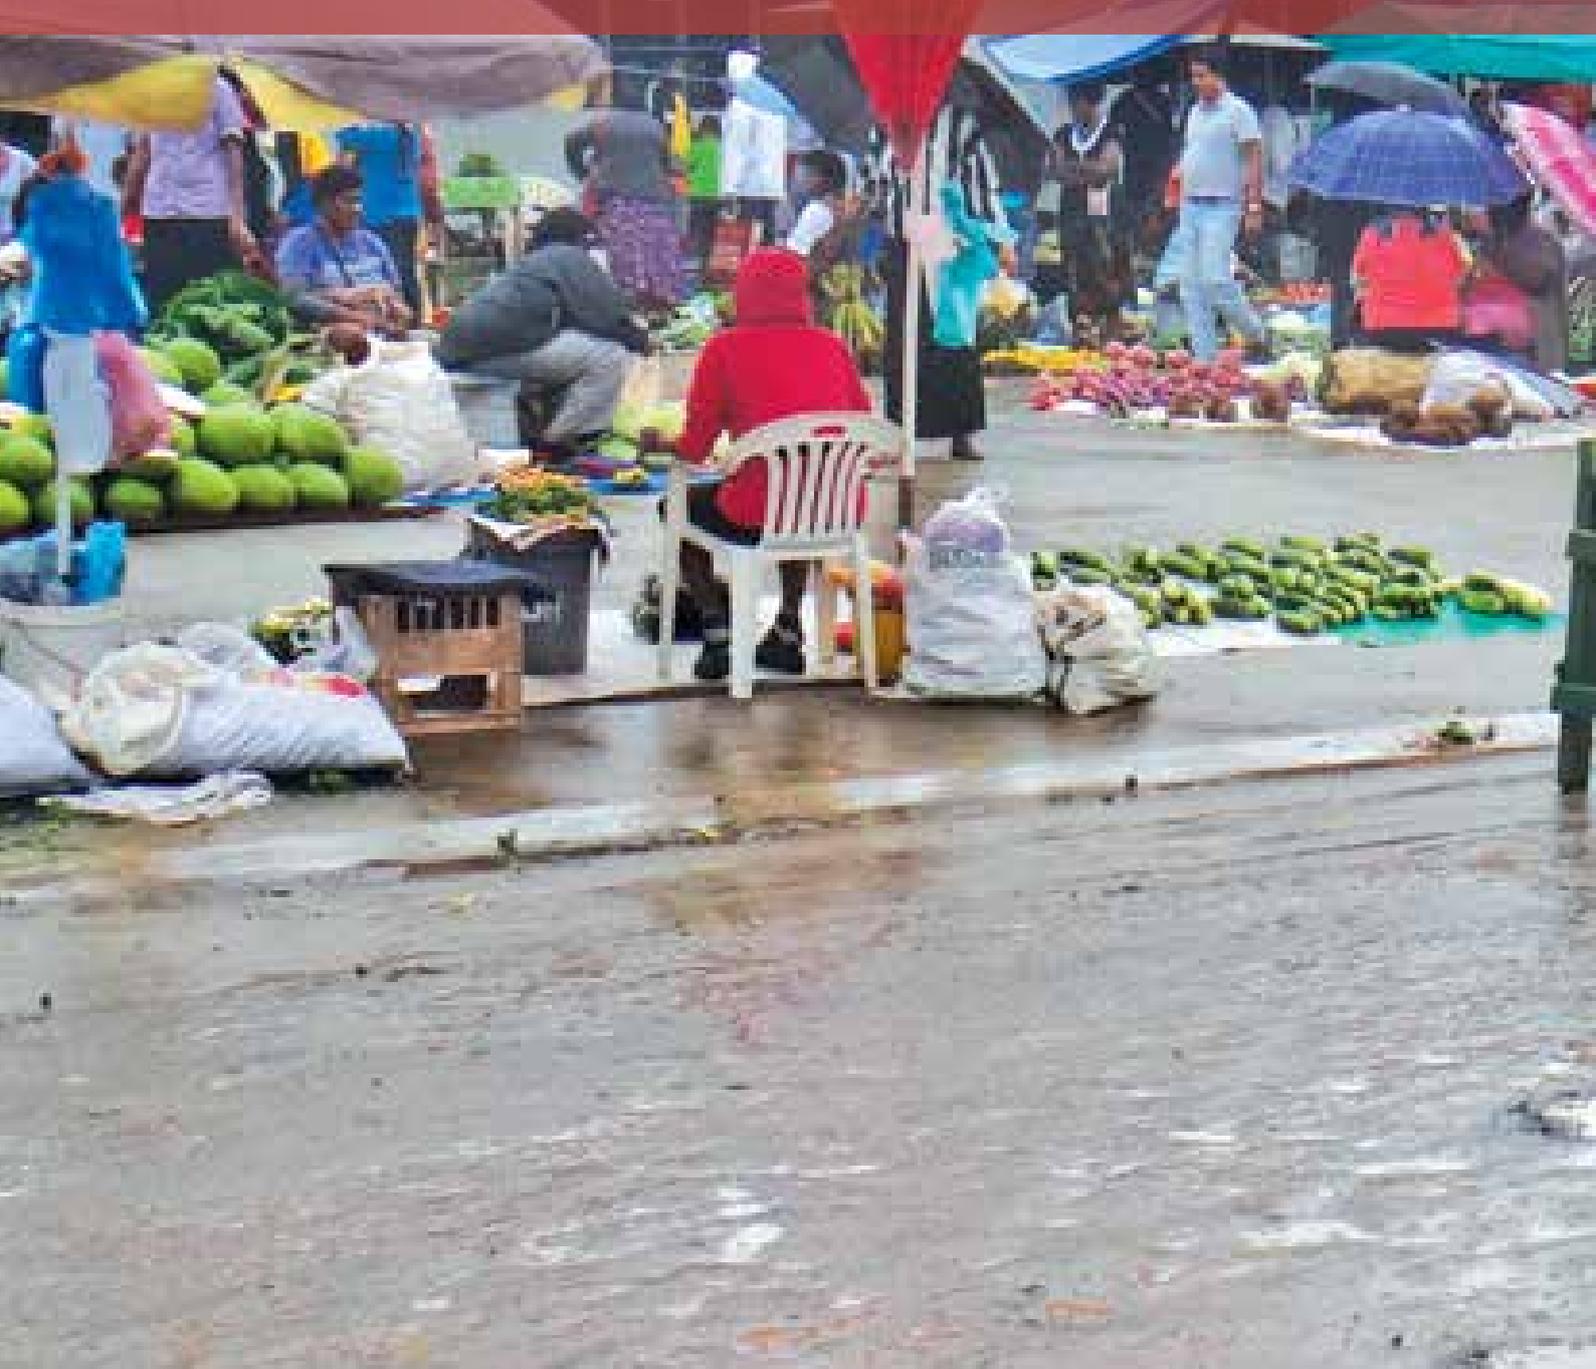
Nausori Market

- New substantial market (largest in Fiji) on new site - opened 2015
 - no damage from Cyclone Winston
- No leakages from roof, and no use of internal taps within market hall, makes floor surface dry
- Good aisle width between permanent stalls, and good signage throughout, including emergency exit signs
- Casual vendors selling outside exposed to elements
- Overflow car park un-surfaced and very muddy in wet weather
- Ditch containing stream to rear of market prone to water-level rise - though not flooded to date.
- Dry goods section of market located closest to ditch - bulky goods stored on floor
- Pedestrian crossing - lights not adhered to by pedestrians and perilous crossing practices

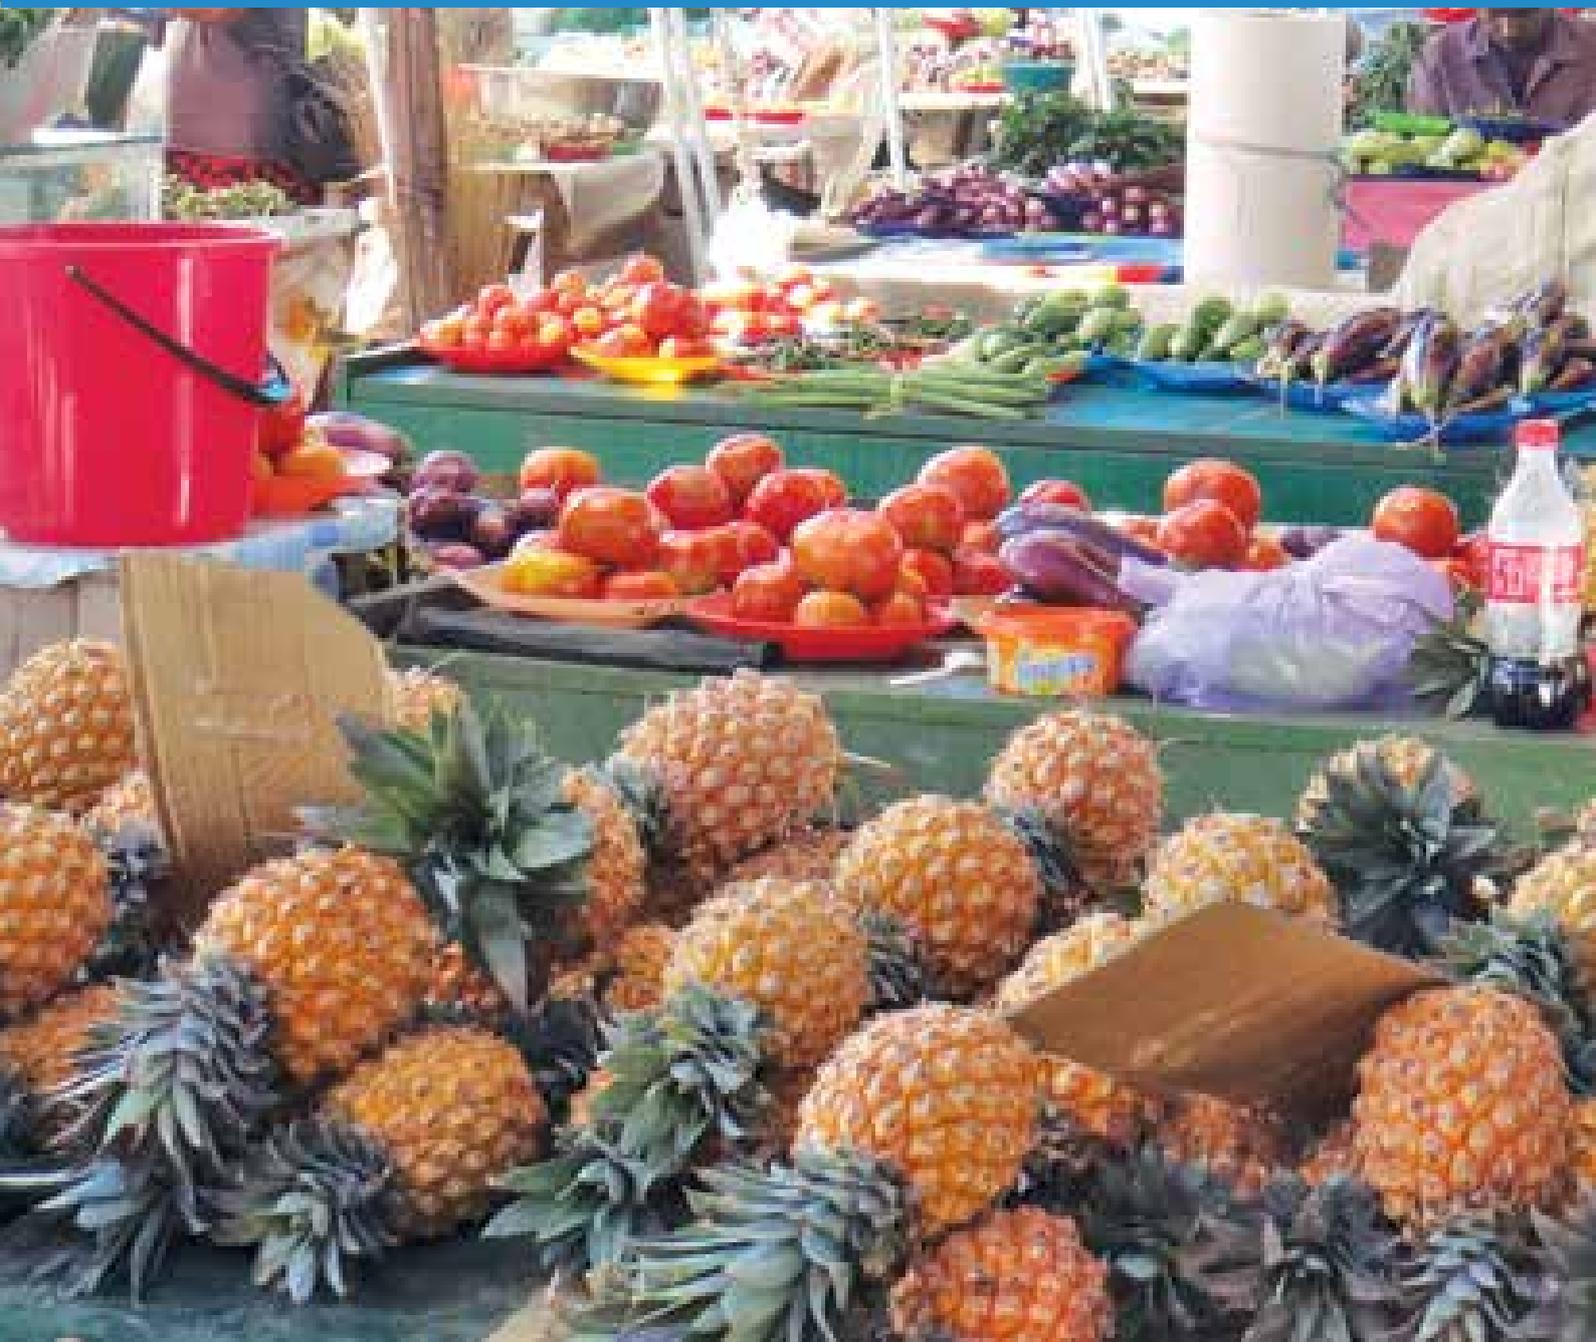
Rakiraki Market (also known as Vaileka Market)

- Very frequent, severe flooding - proximity of tributary of Penang River, and development in town and flood plain
- Extensive damage from Cyclone Winston, resulting in plans for new market
- Casual vendors displaced from new shed to again open, floor-based selling because of cyclone
- Rakiraki constantly windy and produce in new shed wind - damaged on tables; kava section produce blown off tables in strong wind
- Tattered tarpaulin protection from afternoon sun along tents section
- Extensive tarpaulin sheeting erected daily by council to protect 'wing' containing dry goods
- No running water (tap) in fish market and no ventilation fan
- Dusty gravel car park and no shade because of loss of trees in market square

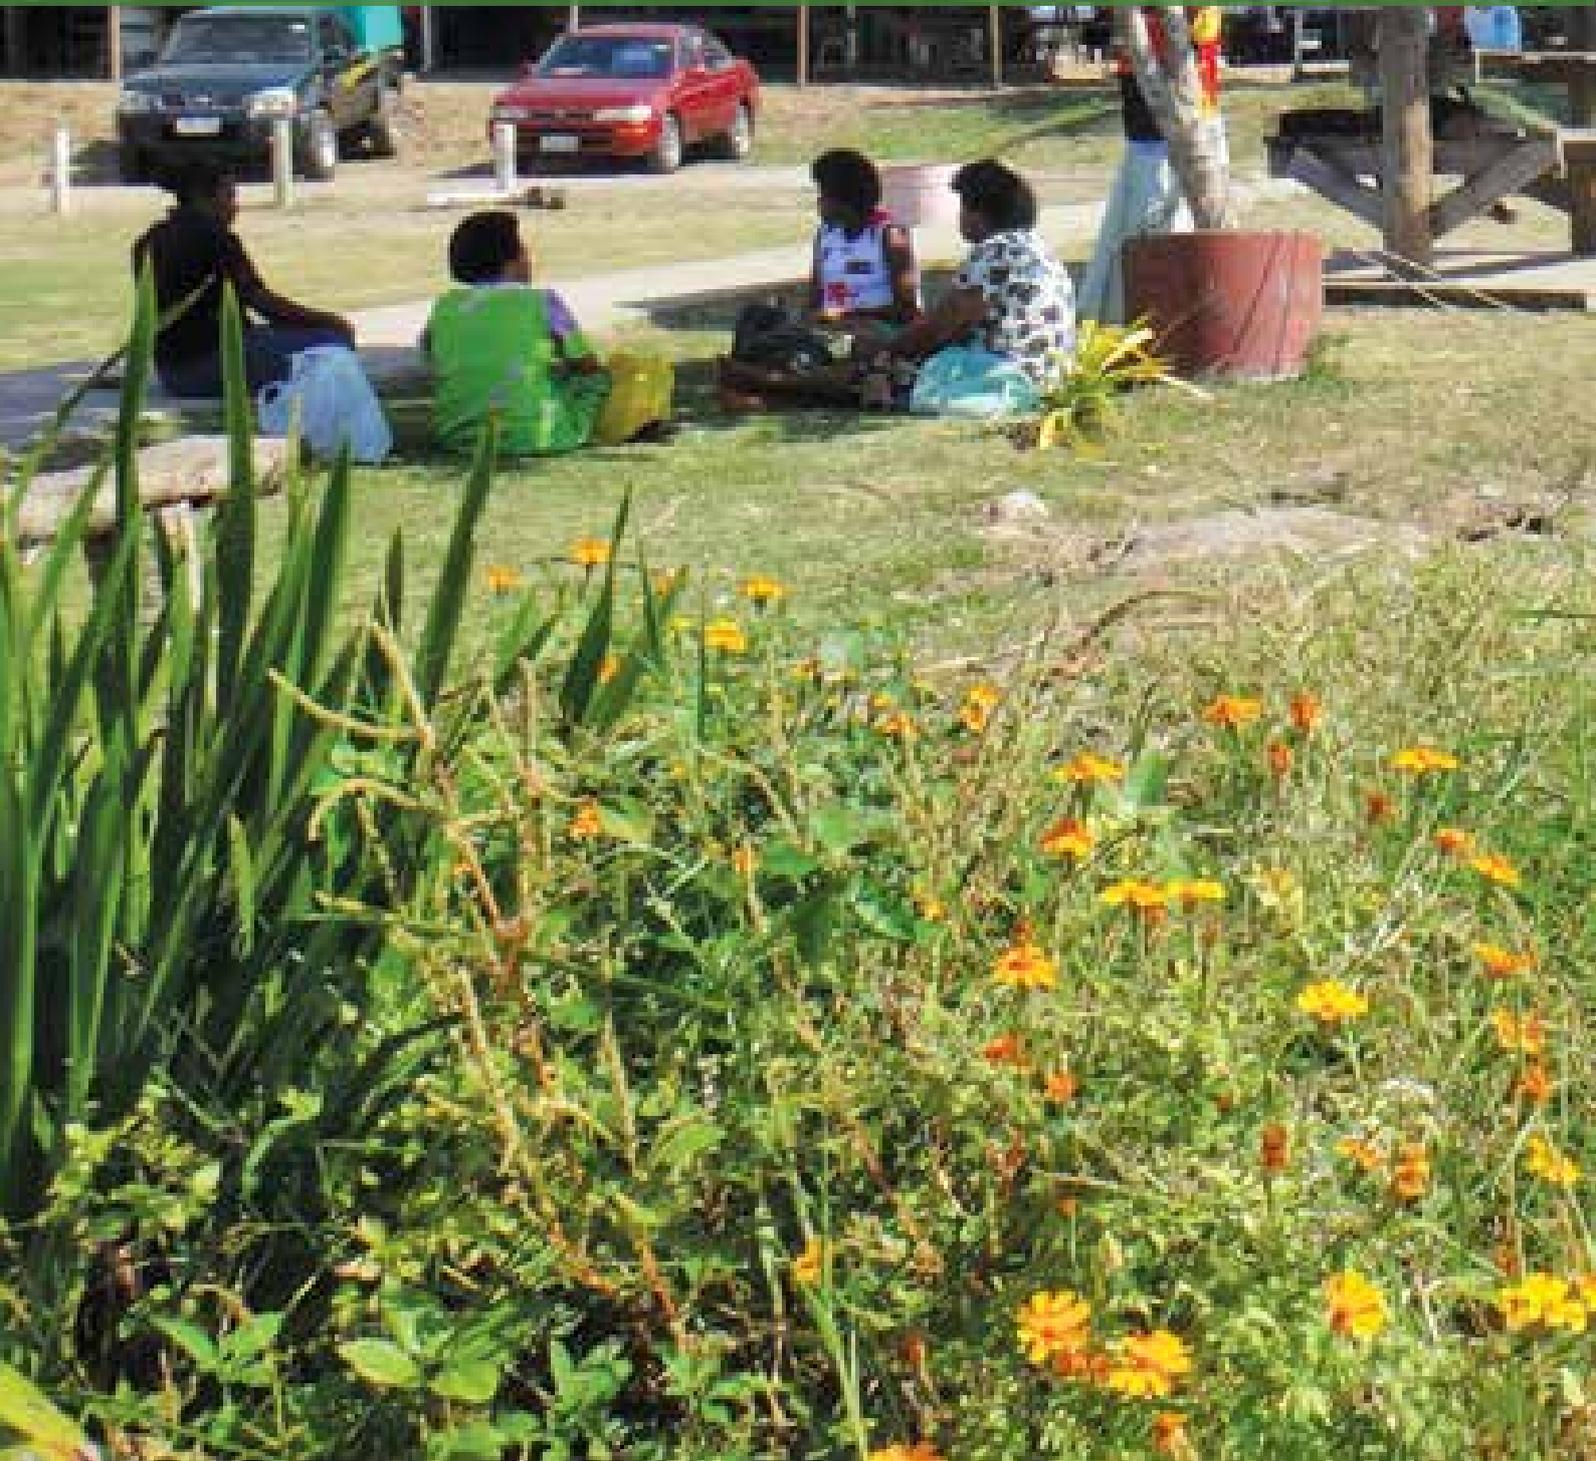
Savusavu Market

- No past flooding - no riverine source close by - Vunikoka Creek to one side of market
- Plans to develop partial two-storey extension
- Proximity of the coast, and risk of storm surge and tsunami
- All casual vendors sell from tables, not from the floor
- Older, low-ceilinged section of market poor ventilation and hot in hot season
- Fish sales from new extension, stored in vendor-owned chiller cabinets - no back-up generator
- Flower vendors on Saturdays, and unprotected from elements
- Separate food parcels shed open-sided and unsecure
