CLIMATE CHANGE & MARKETS FOR CHANGE PROGRAMMES

BUILDING MARKET RESILIENCE TO CLIMATE CHANGE

FIJI ASSESSMENT REPORT
DECEMBER 2016

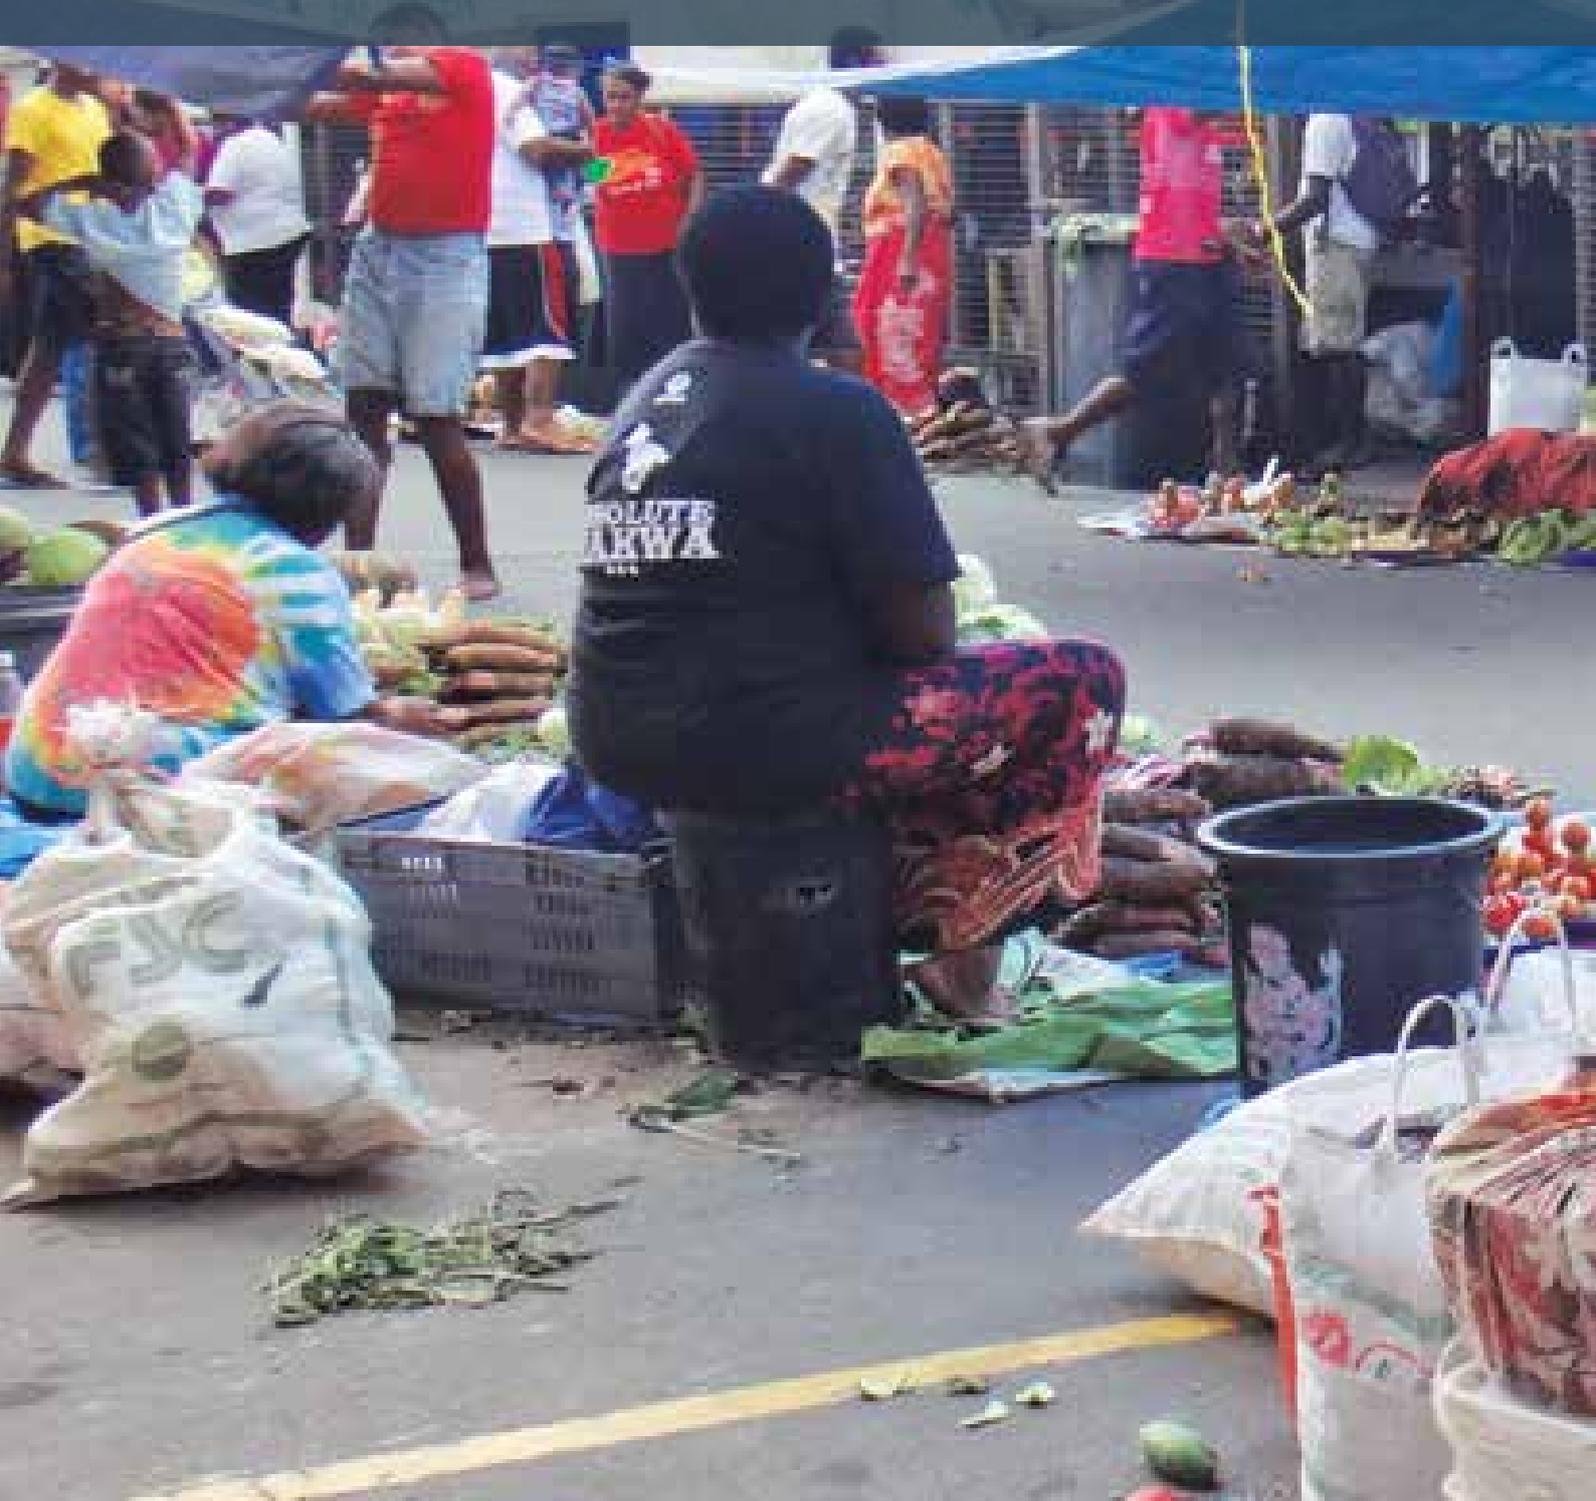
Sigatoka Market

- Sigatoka area important supplier of produce - the 'salad bowl of Fiji'
- Plans for relocation of market, bus stand and council offices to Lawaqa Road, Sigatoka
- Market and town situated in a high-risk earthquake zone
- Women account for 89% of casual vendors, who sell unprotected from floor
- Overhead guttering between old and new extension leaks throughout; and roof leakage elsewhere
- Market is lockable, with extensive security - camera coverage - no night - time security staff
- Toilets use local borehole for water supply - stored in water tanks aloft
- Fish and *kai* section mixed in with fruit and vegetables - odour and water nuisance

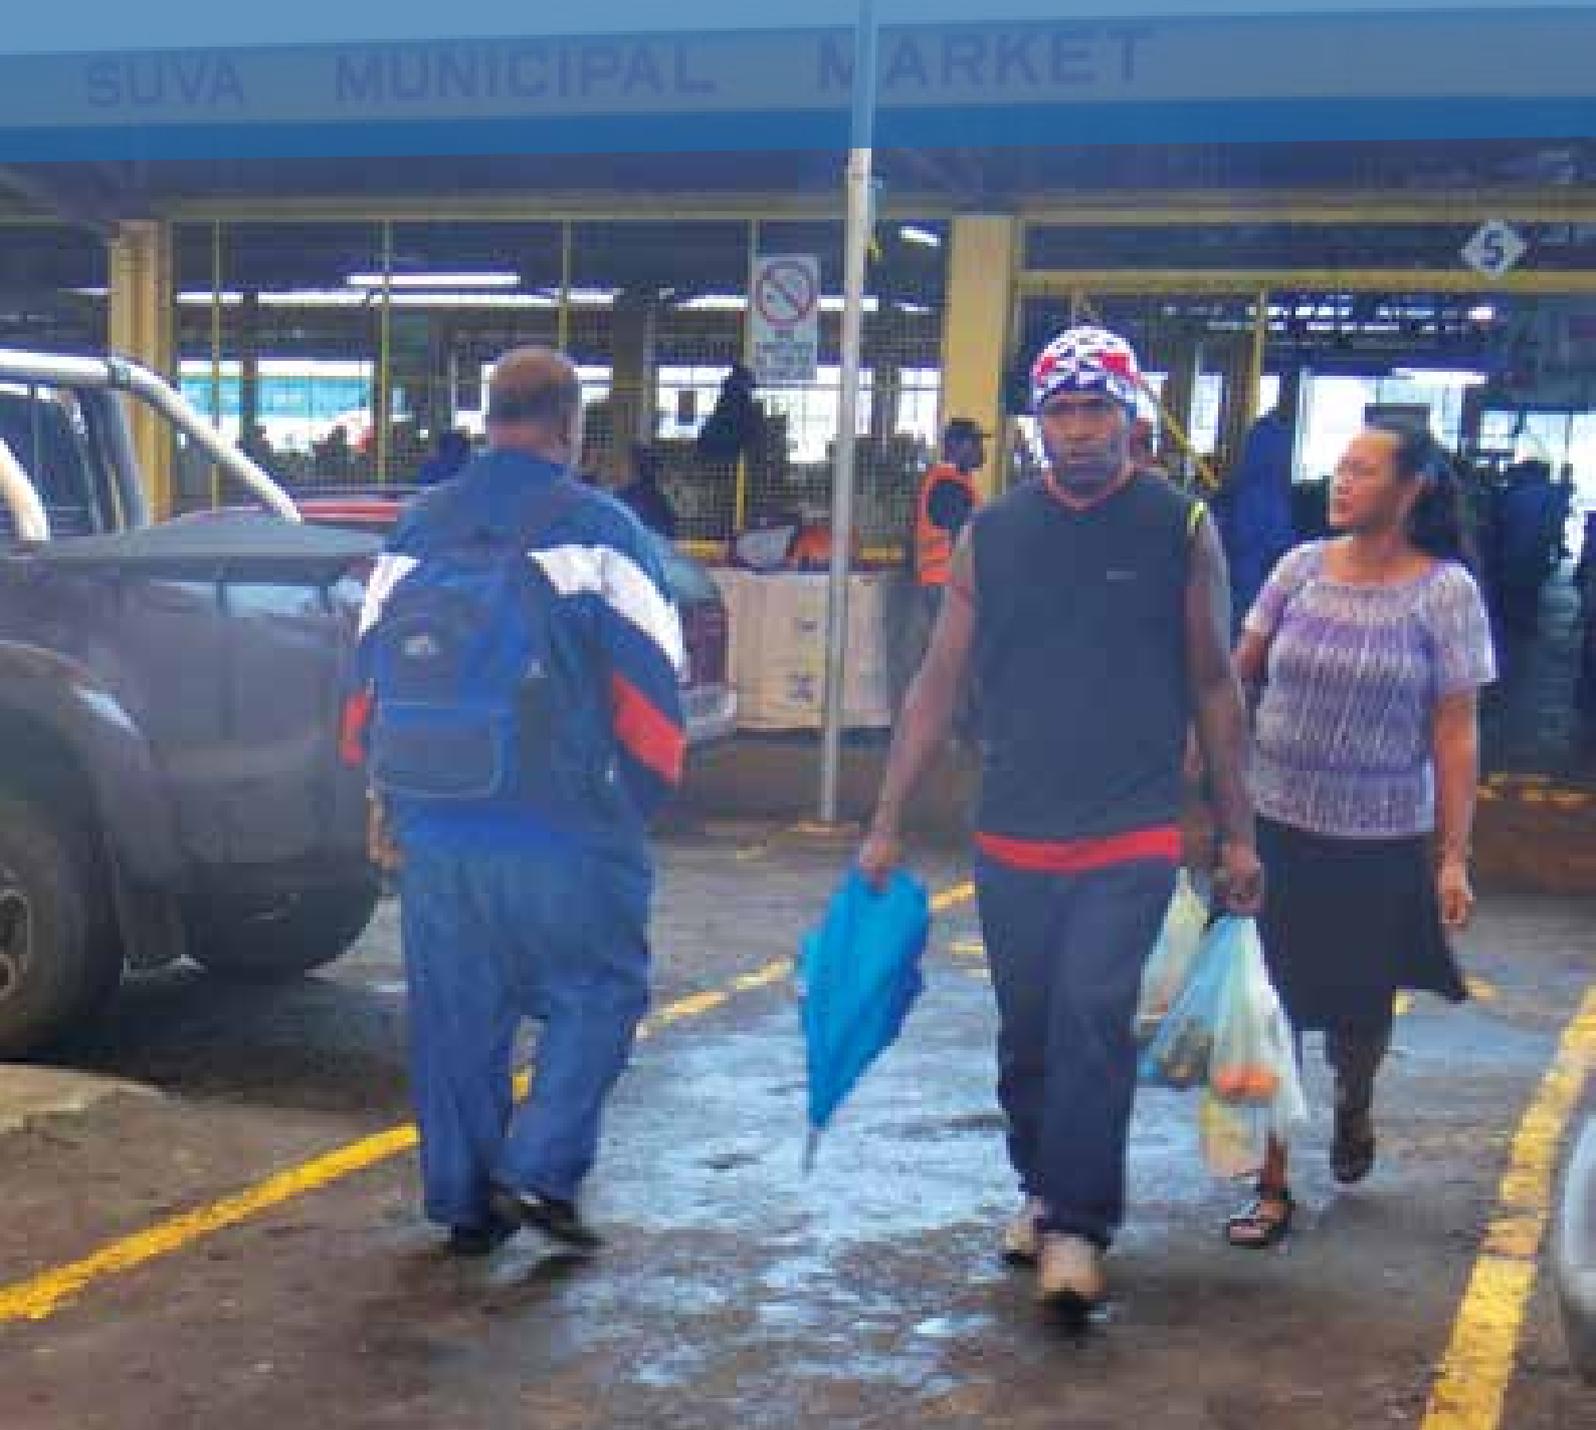
Suva Market

- Market sited on reclaimed land and within a high - risk earthquake zone
- Tsunami risk because of proximity of coast
- Plans for major new market within area of current market and bus stand
- Casual vendors (75% of whom are women) travel considerable distance in community carriers to sell outdoors at market
- High customer footfall on Saturdays in confined space
- Constant wet floor in main produce hall because of internal taps, and risk of flooding from internal drainage system - legacy of original market drainage
- High-level tarpaulin tents have rain - generated stretch 'bubbles', requiring regular replacement
- Only vendors' toilets, upstairs, inadequate in number, and in poor sanitary condition

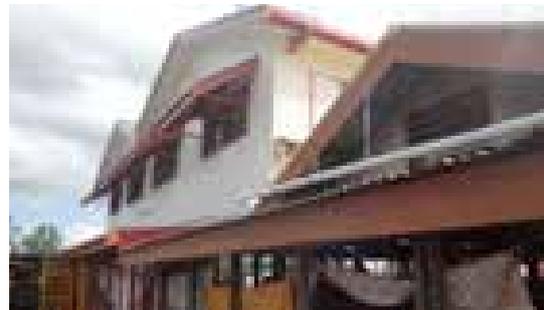
Labasa Market: Shutters shade upper windows and act as storm shutters

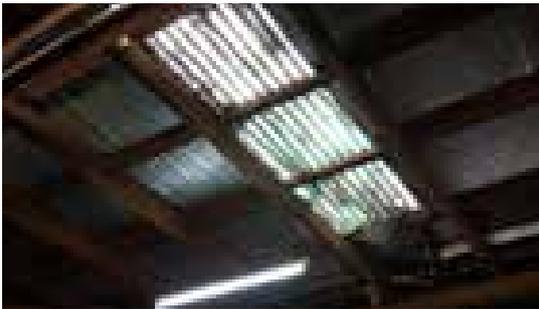
Interior lighting levels can also be a concern. To add light below, Perspex tiles are fitted in the roofs of several markets (Ba, Labasa, Nadi, Rakiraki) to enable daylight to penetrate to the area below. However, in almost all cases where Perspex is installed, the transparent panels have either been painted over in a darker colour or covered with temporary materials e.g. cardboard, as too

Nadi Market: Partly obscured, transparent roof lights (tiles)

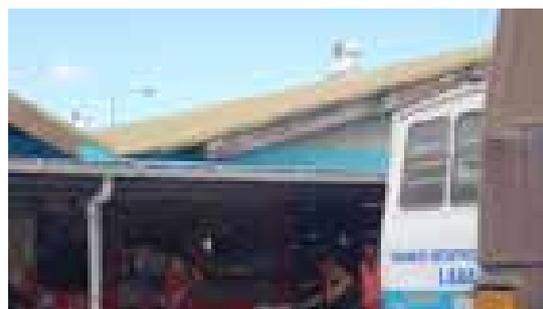
vendors either comment that vents do not solve circulation issues, or, indeed, that they add to the heat within, as the air on the outside of sun-baked roofs is hotter than that inside.

Labasa Market: Vendors claim vents in roof add to heat owing to high temperatures outside

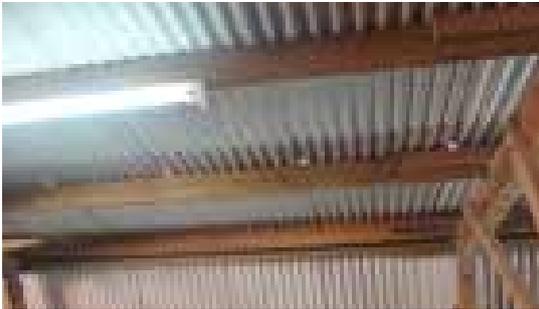
The lining of the roof is an important aid in helping to keep a produce hall cool; unlined corrugated iron (tin) gets particularly hot. The addition of a

Labasa Market: Hot tin roof, with no lining nor ventilation

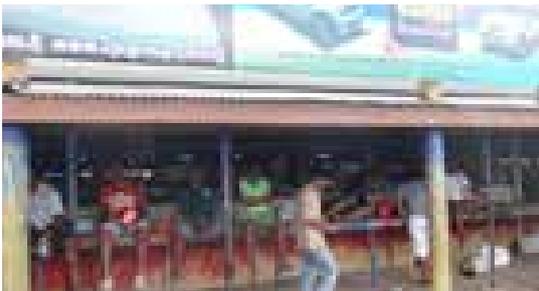
Labasa Market: Roof without guttering

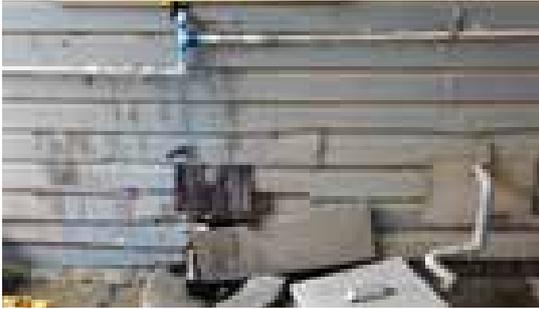
Nadi Market: Contents of downpipes of restaurant seep through walls

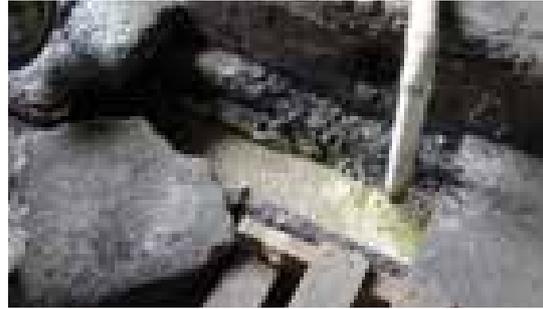
Nadi Market: Poor drainage from restaurant results in foul smelling drain

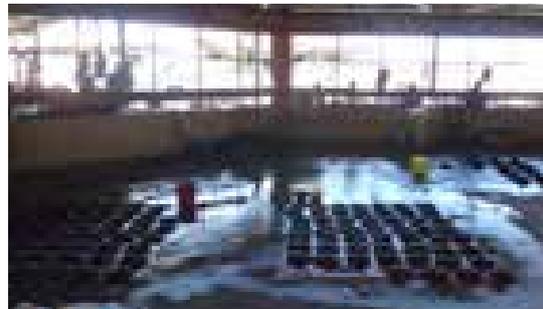
Ba Market: *Kai* section separate section of inside market

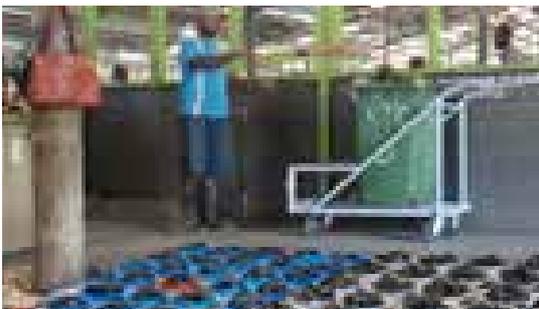
Nadi Market: *Kai* sales on floor near drain, and close to rubbish collection

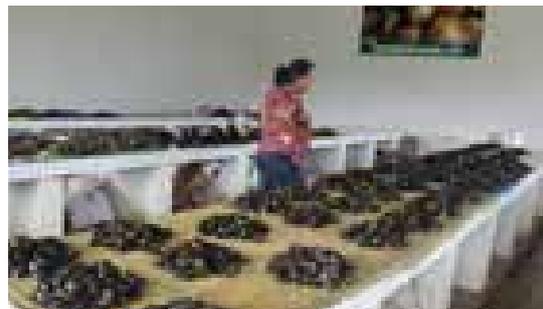
Nausori Market: *Kai* market - purpose-built, separate annex (room)

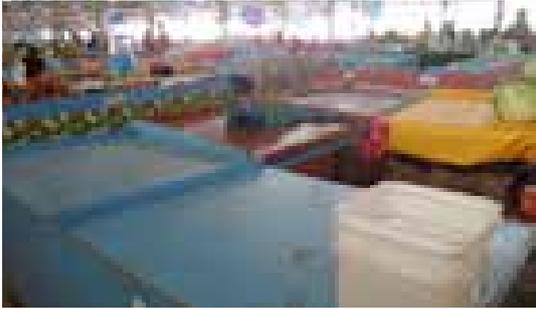
Nausori Market: Wide displays and wide aisles for ease of access

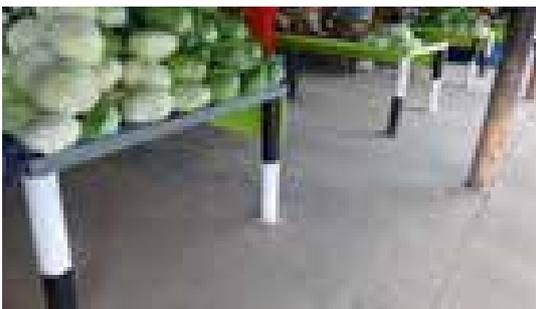
Recently, Ba Market had rows of flood-resistant, fixed, metal tables installed, which it is hoped, will withstand a future flood. Nadi Market also has fixed tables in the new extension, but they already show signs of wear, and so far have not been exposed to flood water.

Ba Market: Fixed, flood-proof metal tables

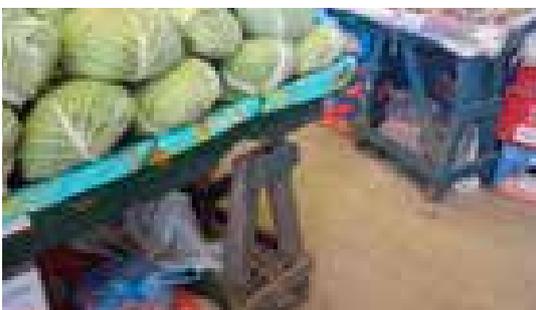
Rakiraki Market: Tables from Nausori old market replaced those lost in Winston

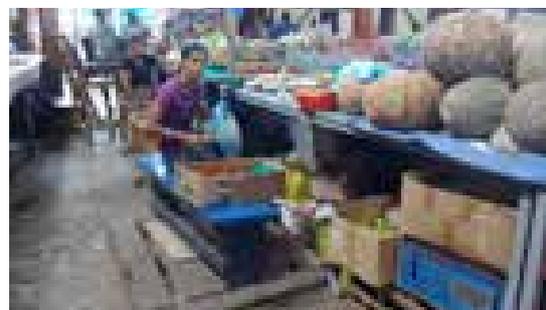
Lautoka vendors complain that their new tables in the new extension are too high, and many of the vendors use a variety of techniques to prop up their own seating.

Lautoka Market: Vendors' raised seating in new extension

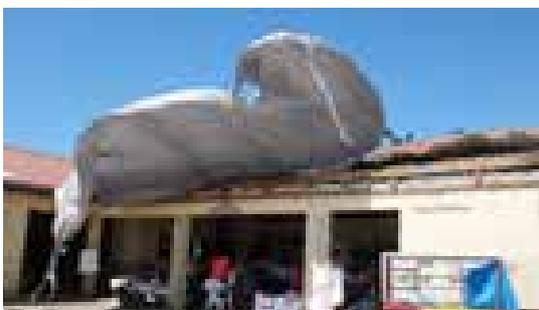
Rakiraki Market: Temporary tarpaulin caught in high winds

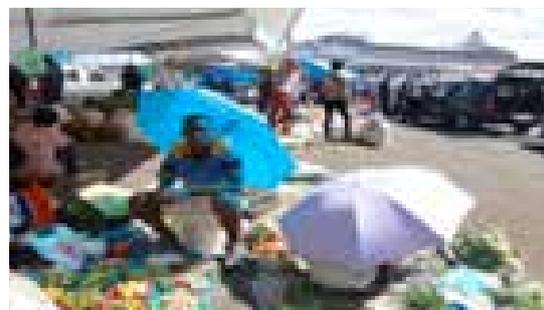
Suva Market: Casual vendors sell in the hot sun on Saturdays

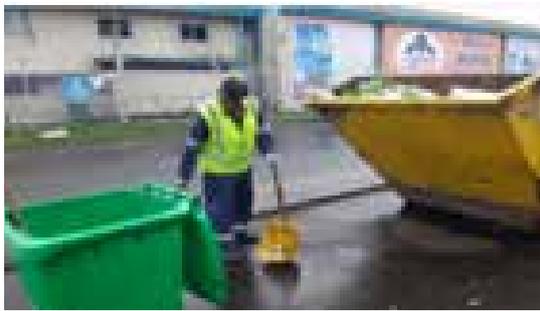
Suva Market: Waste segregation in operation

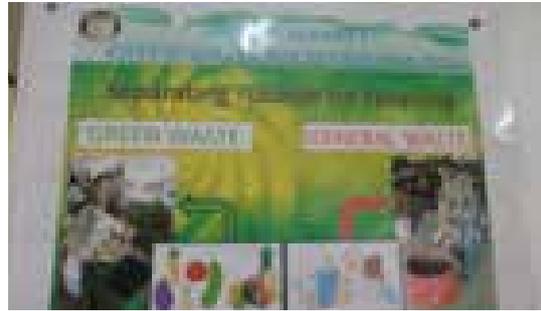
Labasa Market: Signage promotes waste segregation in council offices

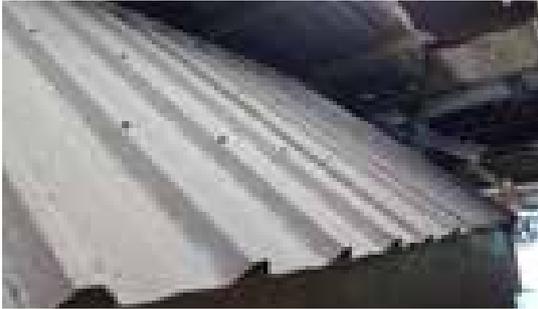
Ba Market: Internal roof demonstrates build up of dust

and walls are seldom cleaned, and dust levels build up, causing respiratory problems among vendors. Ba Market is particularly dusty at height (in the rafters). And markets with operational fans

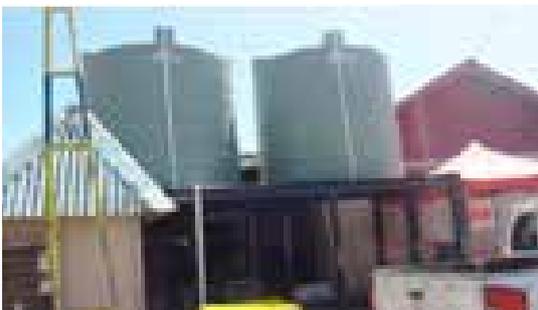
Sigatoka Market: Local bore hole used as water source for toilets

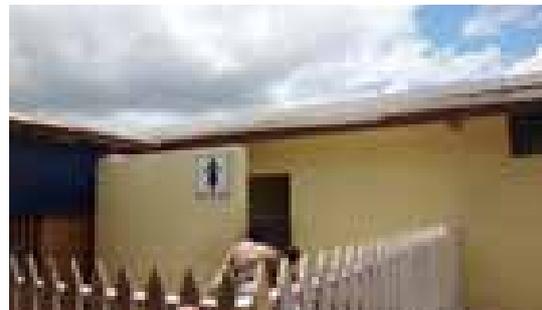
Labasa Market: Toilets with alternative water tanks

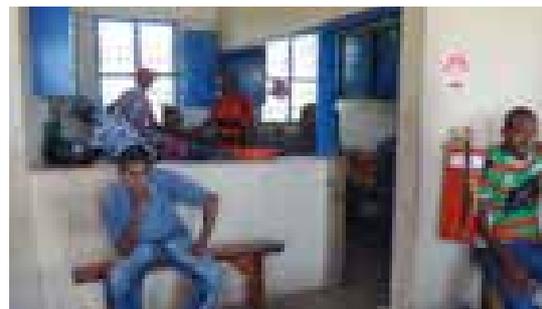
Rakiraki Market: Fire extinguisher near mixed kava vendors' room

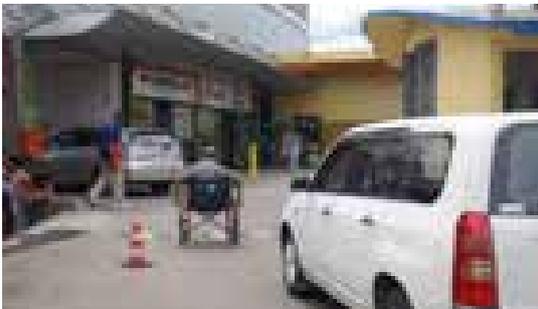
Lautoka Market: Wheelchair user interacting with traffic in side street

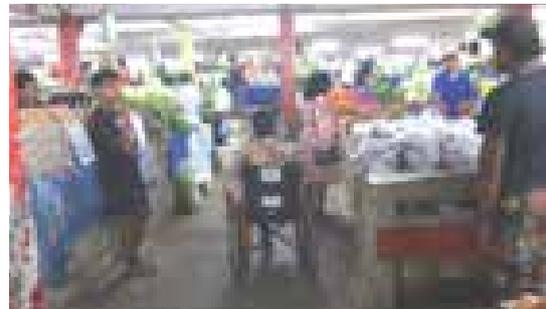
Suva Market: Wheelchair use in the main produce hall

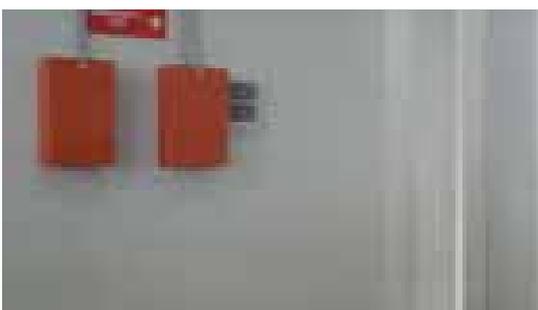
Nausori Market: (Small) emergency signage indicates hidden exit

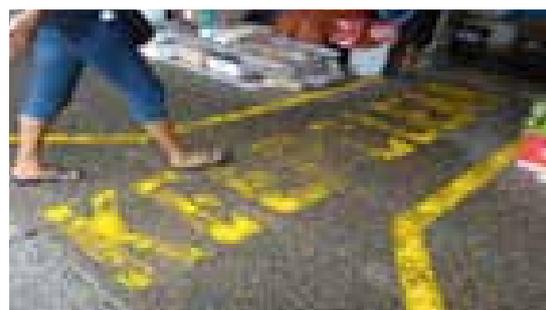
Suva Market: Keep clear signs indicate access, and generally adhered to

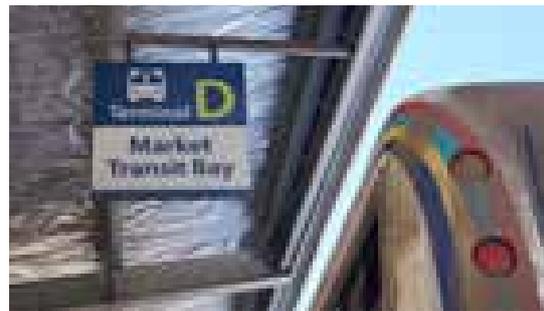
Nausori Market: Dedicated market transit bay close to market
